# **2022 Update: County of Santa Cruz Stream Crossing Inventory and Fish Passage Evaluation**

September 12, 2022

Prepared by Kristen Kittleson, County of Santa Cruz Fishery Resource Planner  
Water Resources Program, Environmental Health, Health Services Agency

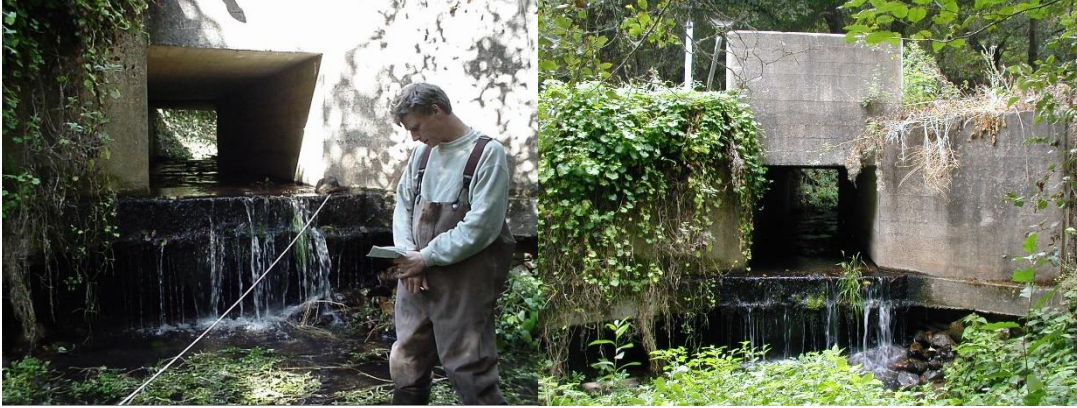
**West Liddell Creek #1/Bonny Doon Road (PM 0.69)** – A full replacement would benefit passage for steelhead, possibly coho salmon, red-legged frog and western pond turtle. Culvert replacement would also benefit public safety since Bonny Doon Road is an important emergency access route from Bonny Doon and San Lorenzo Valley communities.

Left: West Liddell #1 at Bonny Doon Road 2002  
Right: West Liddell #1 at Bonny Doon Road 2005

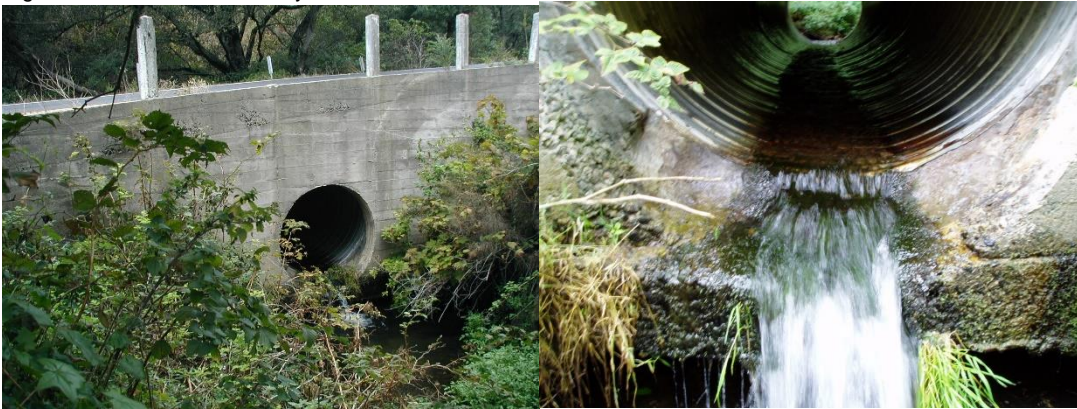
**West Liddell Creek #3/Boony Doon Road (PM 0.94)** - A full replacement would benefit passage for steelhead, possibly coho salmon, red-legged frog and western pond turtle. Steelhead, and coho salmon, continue to use East Liddell Creek. Culvert replacement would also benefit public safety since Bonny Doon Road is an important emergency access route from Bonny Doon and San Lorenzo Valley communities.

Left: West Liddell #3 at Bonny Doon Road 2005  
Right: West Liddell #3 at Bonny Doon Road 2005

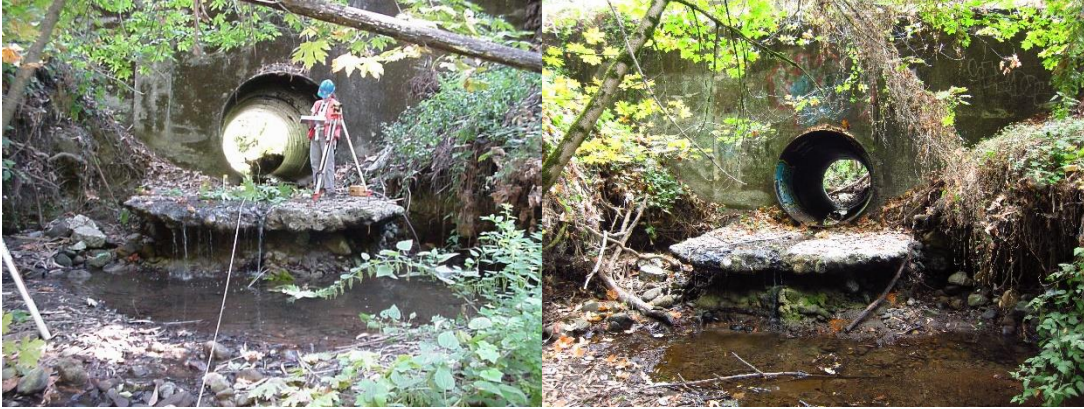
**Cassery Creek #2/Mount Madonna Road (PM 1.00)** – Several years of juvenile steelhead sampling immediately downstream of this culvert indicates that this culvert is a significant barrier. The Pajaro Valley Water Management Agency is working to improve conditions in College Lake for steelhead and there would be significant support for this project. In addition, this culvert is in extremely poor condition and should be replaced.

Left: Casserly at Mount Madonna Road 2002  
Right: Casserly at Mount Madonna Road 2019

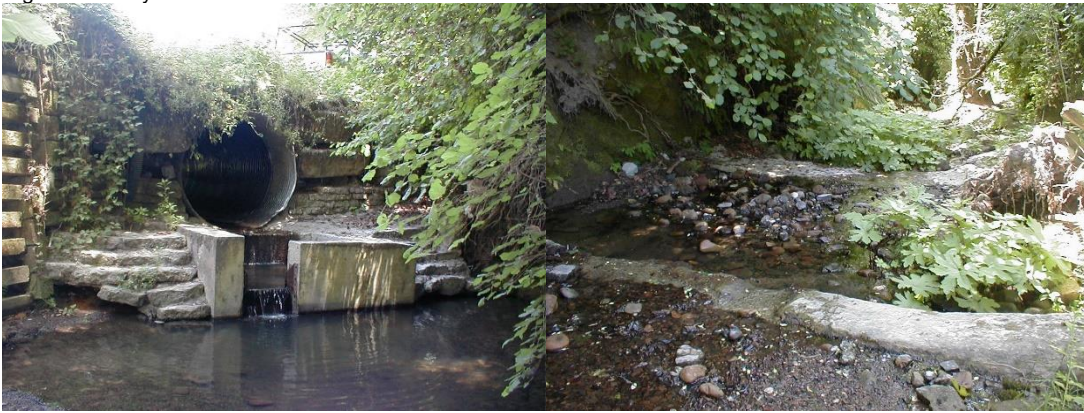
**Cassery Creek #3/Gaffey Road** – This culvert was not included in the original 2004 report. This crossing should be replaced in conjunction with the Cassery Creek at Mount Madonna Road culvert since this culvert is only about 600' upstream and is also in poor

condition. Culvert replacement would provide much improved fish passage to about 2,000' of habitat, but a more detailed habitat assessment would be helpful.

Left: Casserly at Gaffey Road 2004  
Right: Casserly at Gaffey Road, concrete weirs downstream 2004

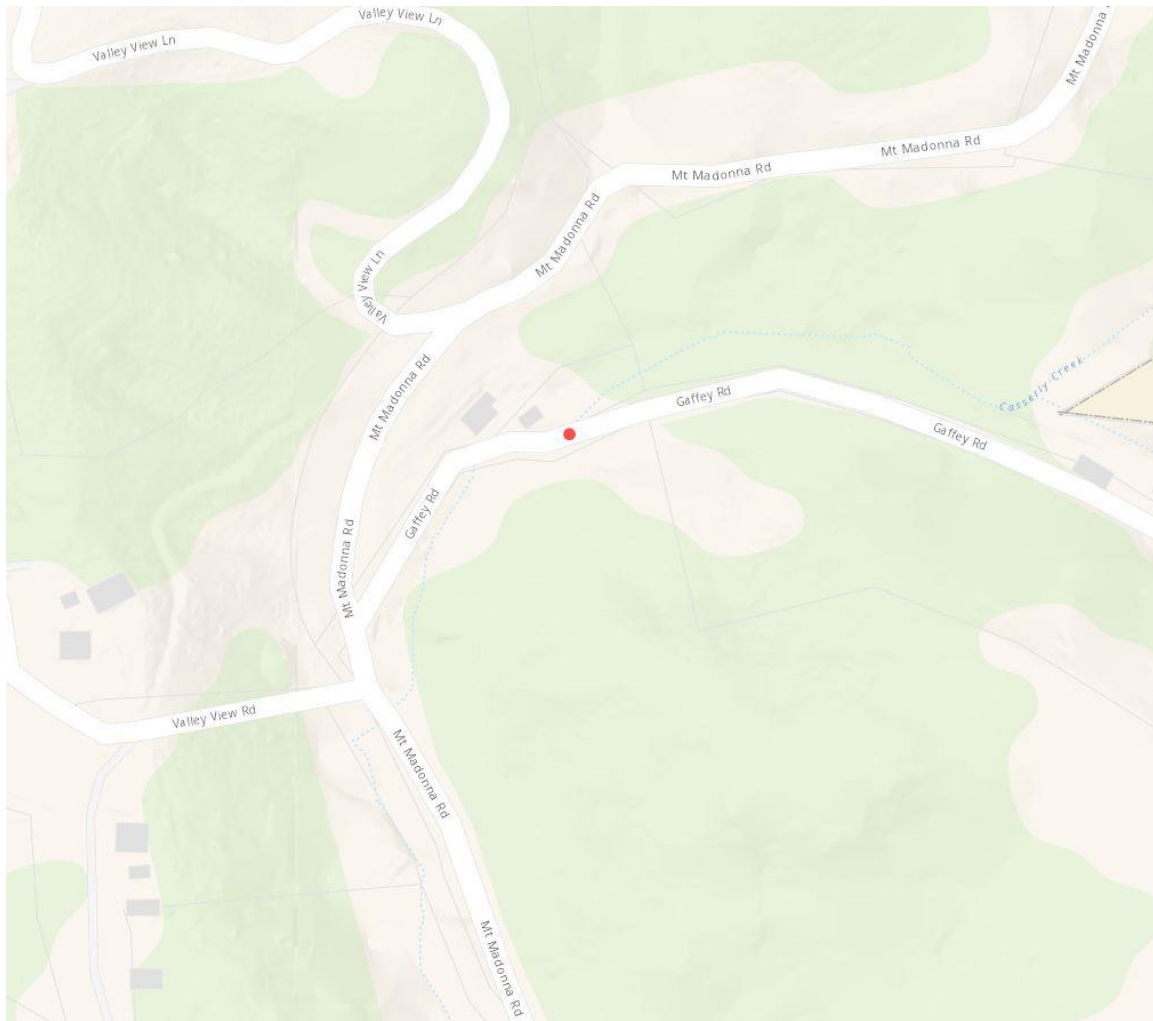
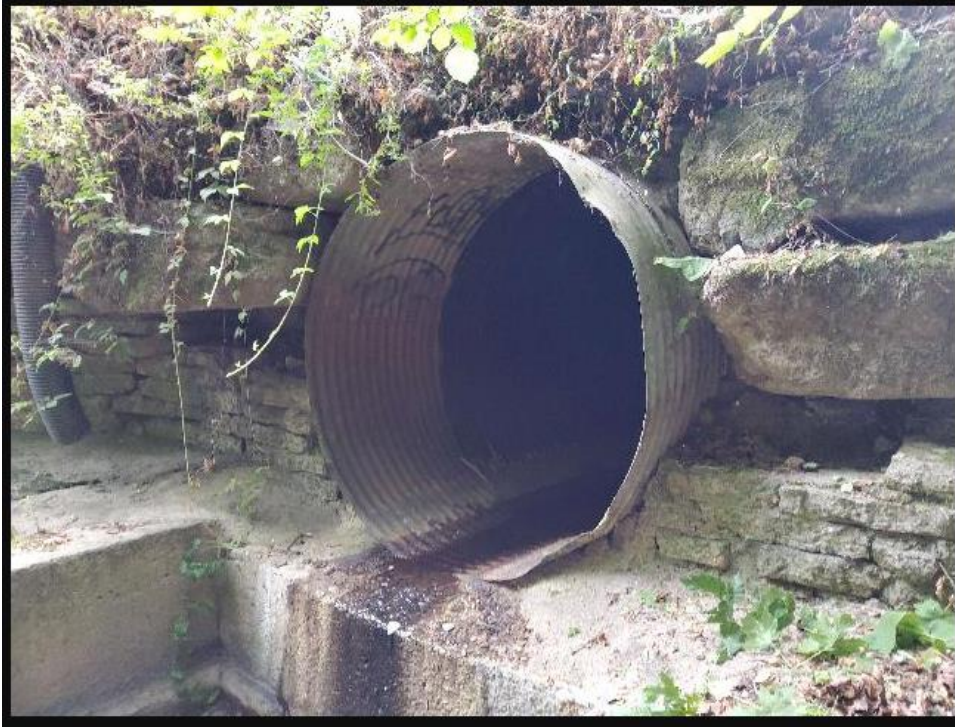
This culvert crossing was not included in the 2004 report. Juvenile steelhead sampling confirm that the culvert at Mount Madonna Road is a significant barrier. This culvert should be replaced in conjunction with the Casserly Creek at Mount Madonna Road culvert, since this culvert is only about 600’ upstream. The County of Santa Cruz previously constructed a box to improve passage at this location.

Outlet: Casserly Creek at Gaffey Road PM 0.80;  
Inside culvert, showing poor condition.

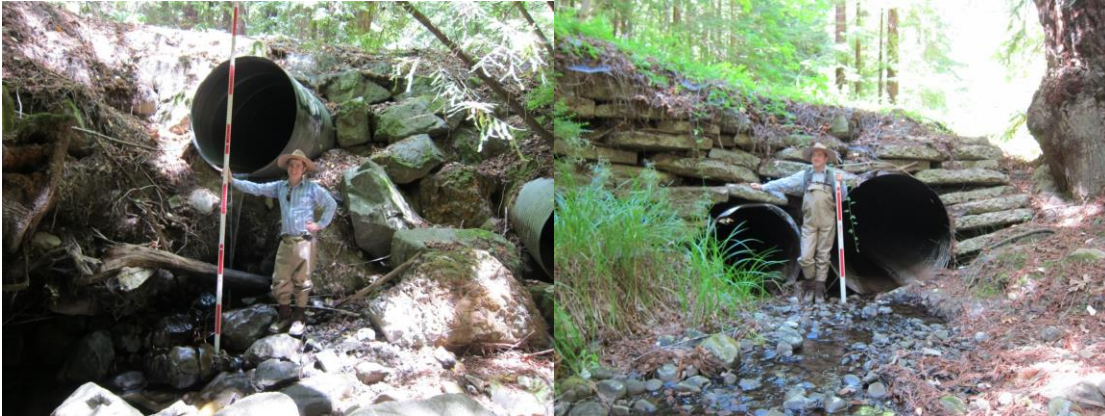
**Site ID #SC-081:** Zayante Creek #1/Upper East Zayante Road; San Lorenzo River

**Culvert Type:** two circular, SSP **Dimensions:** diameters = 5.15' and 3.7'  
**Barrier Status:** RED based on height of jump into culvert (about 6 feet).

This culvert crossing was not included in the 2004 report because it was considered to be upstream of the extent of anadromy. Fieldwork from 2013 confirm that this culvert is upstream of several significant partial passage barriers and is most likely upstream of the extent of anadromy. However, *O. mykiss*, most likely resident steelhead, were found immediately downstream of this culvert indicating that the culvert could be considered the most upstream extent of anadromy on Zayante Creek. Upstream of the culvert, Zayante Creek has low flows and three additional passage barriers within 300'. The area upstream of the culvert is functioning as a Pacific Giant Salamander nursery area. USFWS supports maintaining this culvert barrier to protect this nursery area (J. Martin, personal communication).

Left: Culvert Outlet; Right: Culvert Inlet

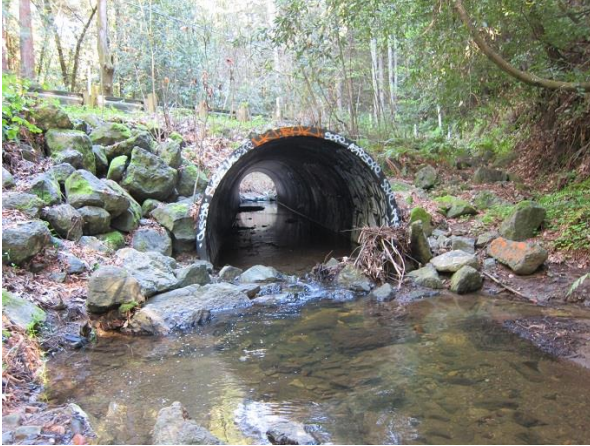
Culvert Outlet

**Barrier Status:** **GRAY** natural stream substrate through culvert, low gradient culvert, but rip rap at culvert inlet creates 1' jump.

This culvert crossing was not included in the 2004 report because the previous culvert was storm damaged and there was no stream crossing during the 2002 fieldwork. In 2003, a new 9' culvert was installed. Natural substrate is found throughout the culvert. Rip rap at the inlet creates a 1' jump. On June 4, 2015, young-of-the-year *O. mykiss*, most likely resident steelhead, were observed upstream and downstream of the culvert. A larger resident fish was observed in a pool downstream of the culvert. A project to modify the rip rap could be implemented but should

consider upstream passage conditions in Green Valley Creek.
