Inventory of Historical Structures and Anadromous Fish Passage Conditions in the San Lorenzo River, Santa Cruz County, California

Final Report
November 8, 2023

Prepared by the County of Santa Cruz Water Resources Program,
Environmental Health, Health Services Agency

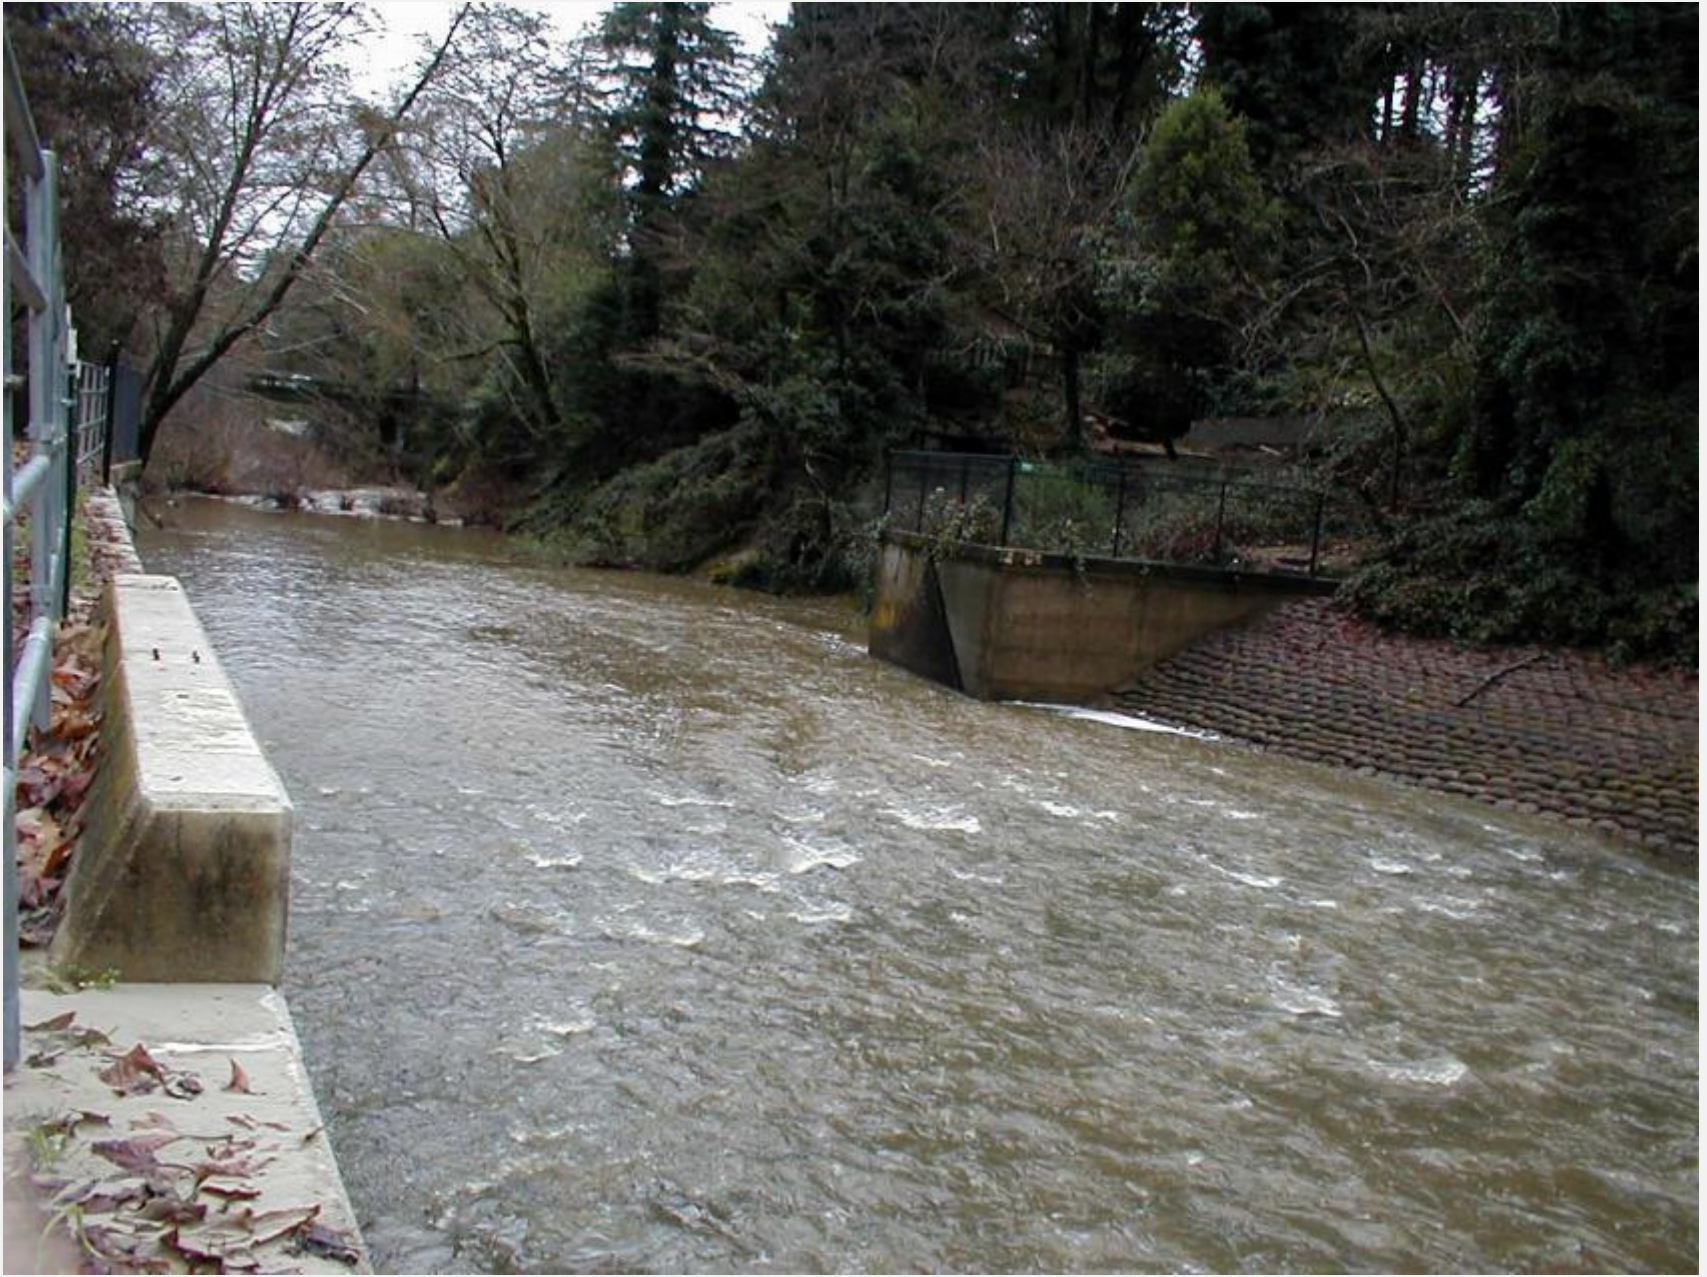
Ben Lomond Park Historical Dam

The historical structure at the County of Santa Cruz Ben Lomond Park has been categorized as a Medium passage severity. The historical dam spillway spans the channel and is a temporal barrier at low flows. During very low flows, there is a drop at the downstream edge with very shallow depths across the spillway. Under moderate flow conditions, the apron is submerged and there is no jump pool at the downstream end. However, at low to moderate flows, depths across the dam spillway can be shallow and fast before the entire structure is more submerged. At moderate and high flows, the entire spillway is submerged and vegetation growing on top of the dam spillway provides roughness and velocity variation that aids passage. While this

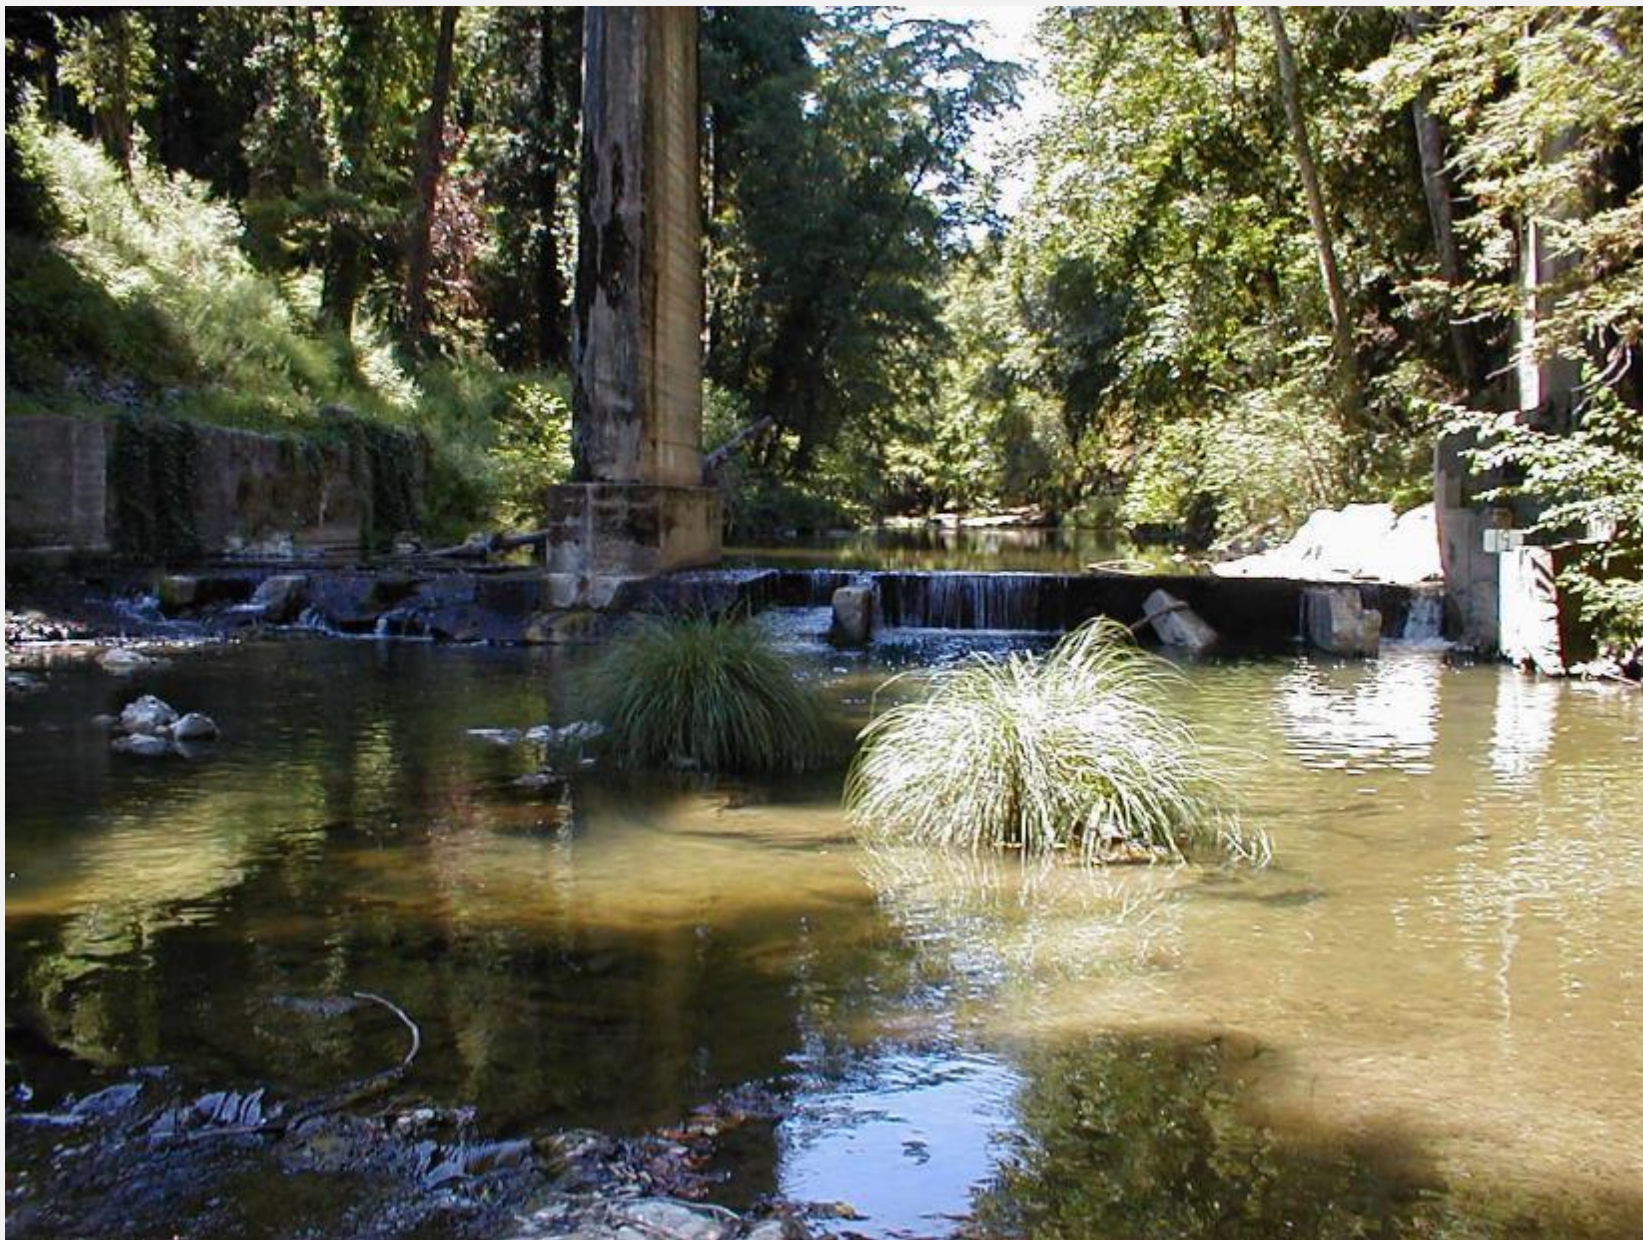
Bridge Foundation PAD ID# 706926 - High Passage Severity

This structure – a bridge with a grade control structure in the channel – is a High Passage Severity due to jump height and position within the Middle River. This structure is the least known significant structure within the Middle River and has not been evaluated under a range of flow conditions. This structure functions as a temporal barrier under low flows and is generally passable at moderate to high flows. The structure could be a partial barrier for upstream juvenile passage due to the jump height.

Fieldwork conducted in 2022 confirmed that the structure's condition remains the same as the 2006 fieldwork and, more importantly, discovered that the bridge serves only to support utility

This structure was identified as a priority project in the San Lorenzo River Enhancement Plan (2004), based in part on the 2001 CDFW study. The Enhancement Plan included conceptual plans to improve passage by notching the bridge foundation towards the left bank, where an existing deep area downstream provides a jump pool. As part of a grant through the County Fish and Game Propagation Fund, the RCD communicated with the property owner, who was concerned that the proposed project could impact the structural integrity of the bridge. Without adequate funding to address these concerns, the property owner declined to work cooperatively with the RCD.

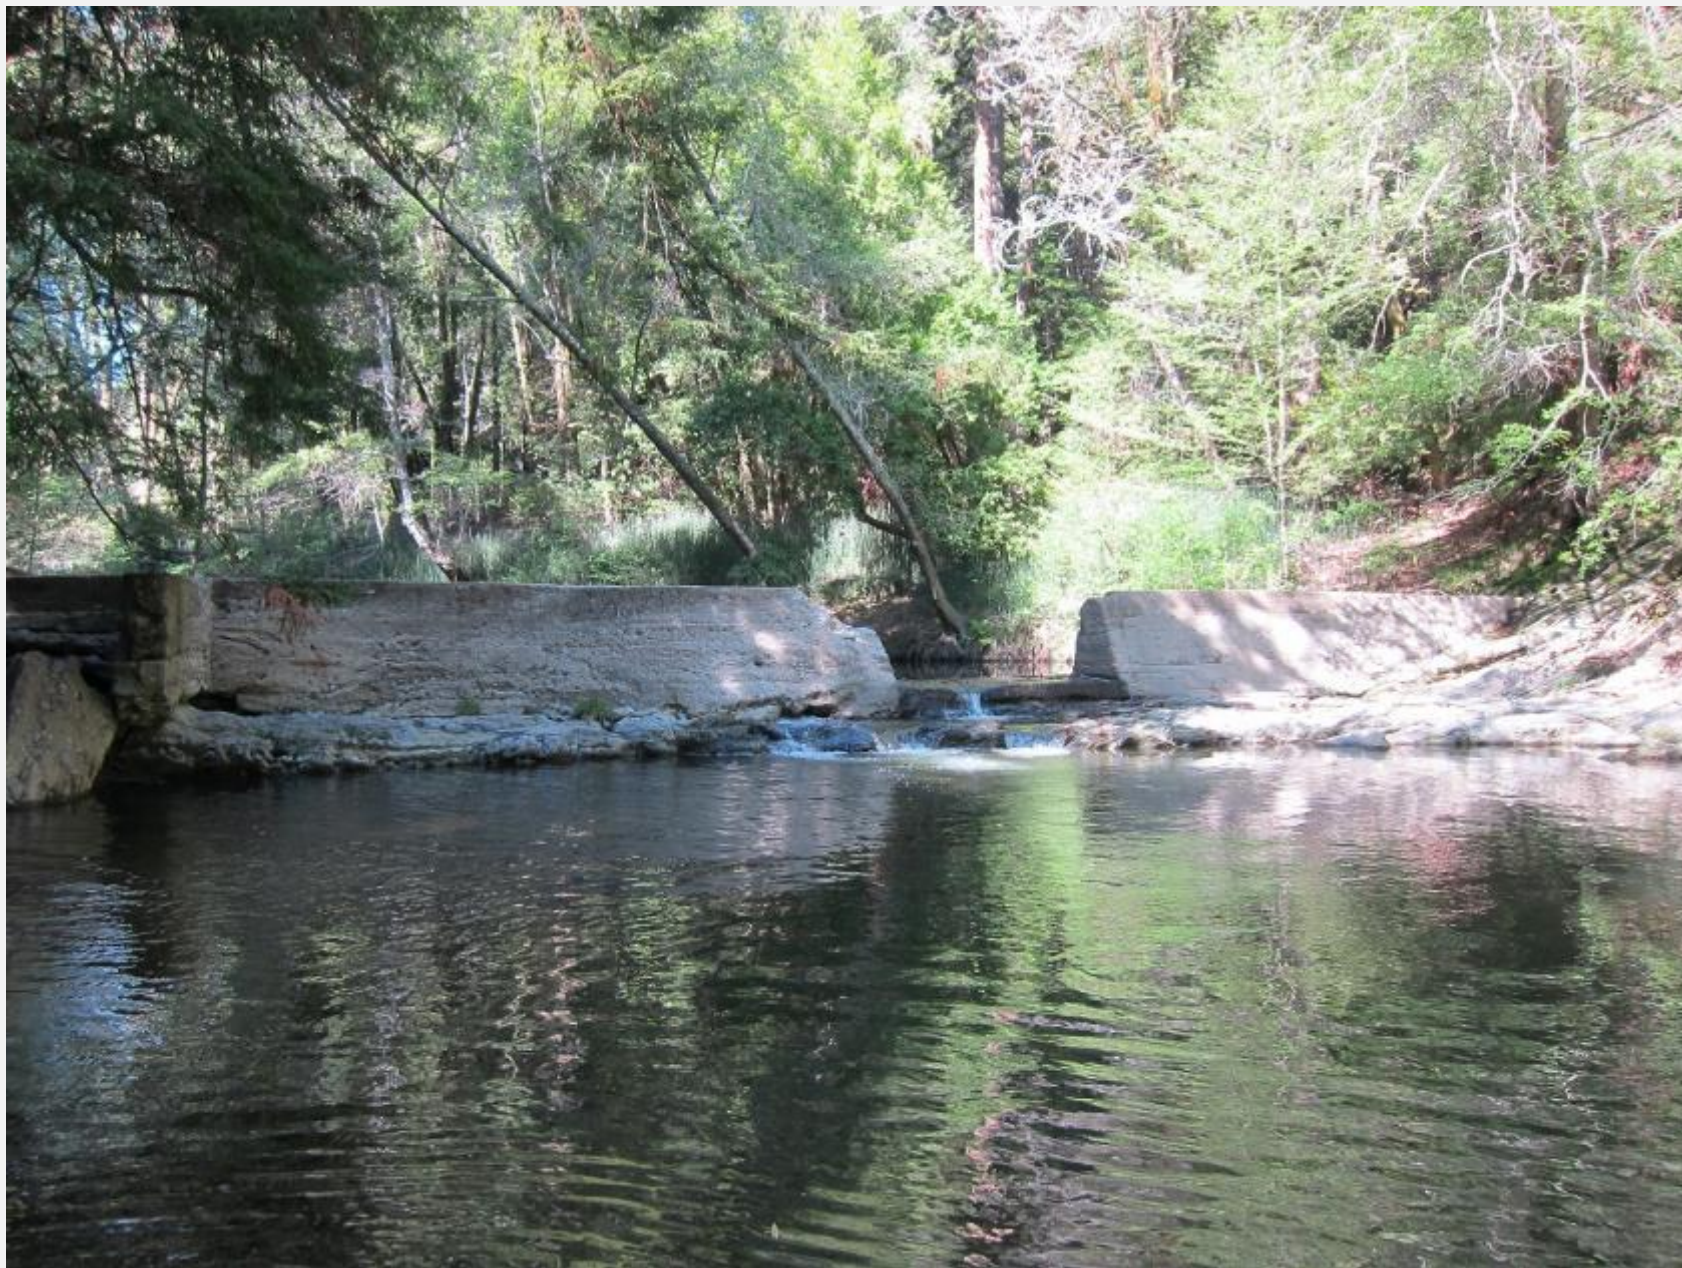
Barker's Dam Historical Structure

This structure is a priority for removal due to its poor condition and location within the Middle River. In addition to the typical passage challenges, voids have developed in the structure that allow low flows to pipe underneath without crossing the spillway. This condition has been observed as creating a complete barrier during low flows in the spring when smolts and adults are migrating downstream. This structure was identified as a priority project in the San Lorenzo River Enhancement Plan (2004) and the RCD invested a substantial amount of time and energy on landowner outreach in 2016. Unfortunately, one of the four property owners was not interested in this voluntary collaboration and project development was halted.

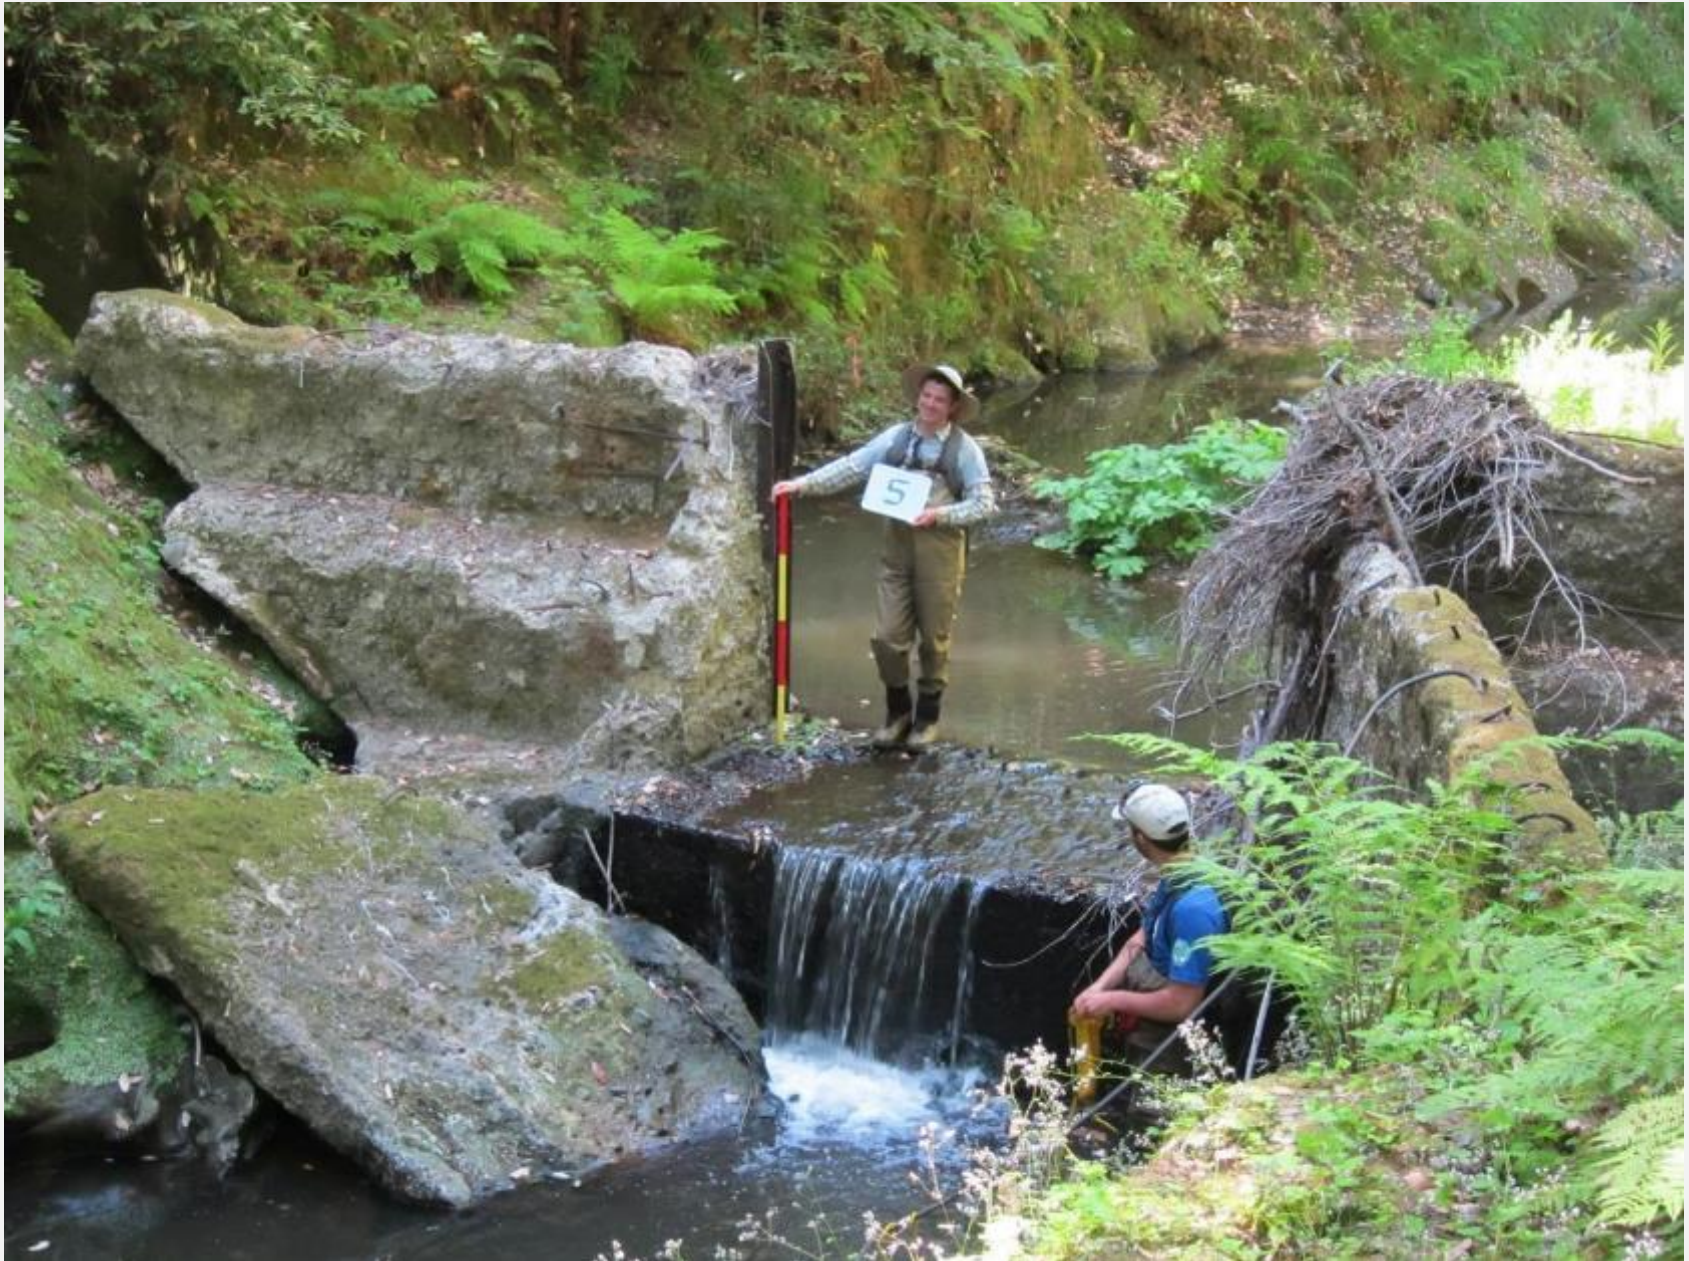
Brimblecom Historical Structure #2

This channel-spanning structure is in poor condition and includes abutments and a spillway. One abutment has collapsed downstream. Passage conditions include a jump pool downstream (3.5-foot), a 3-foot-high jump, and shallow depths over the spillway at low flows.

In 2014, redds were observed upstream of Brimblecom #2, showing that steelhead had access to this area of the Upper River over 2013-14 winter. After a November 9, 2021 storm event with a peak of 157 cfs at Big Trees, about 12 Chinook salmon (*O. tshawytscha*) were observed immediately upstream of this historical structure but downstream of a wood complex on November 21, 2021.

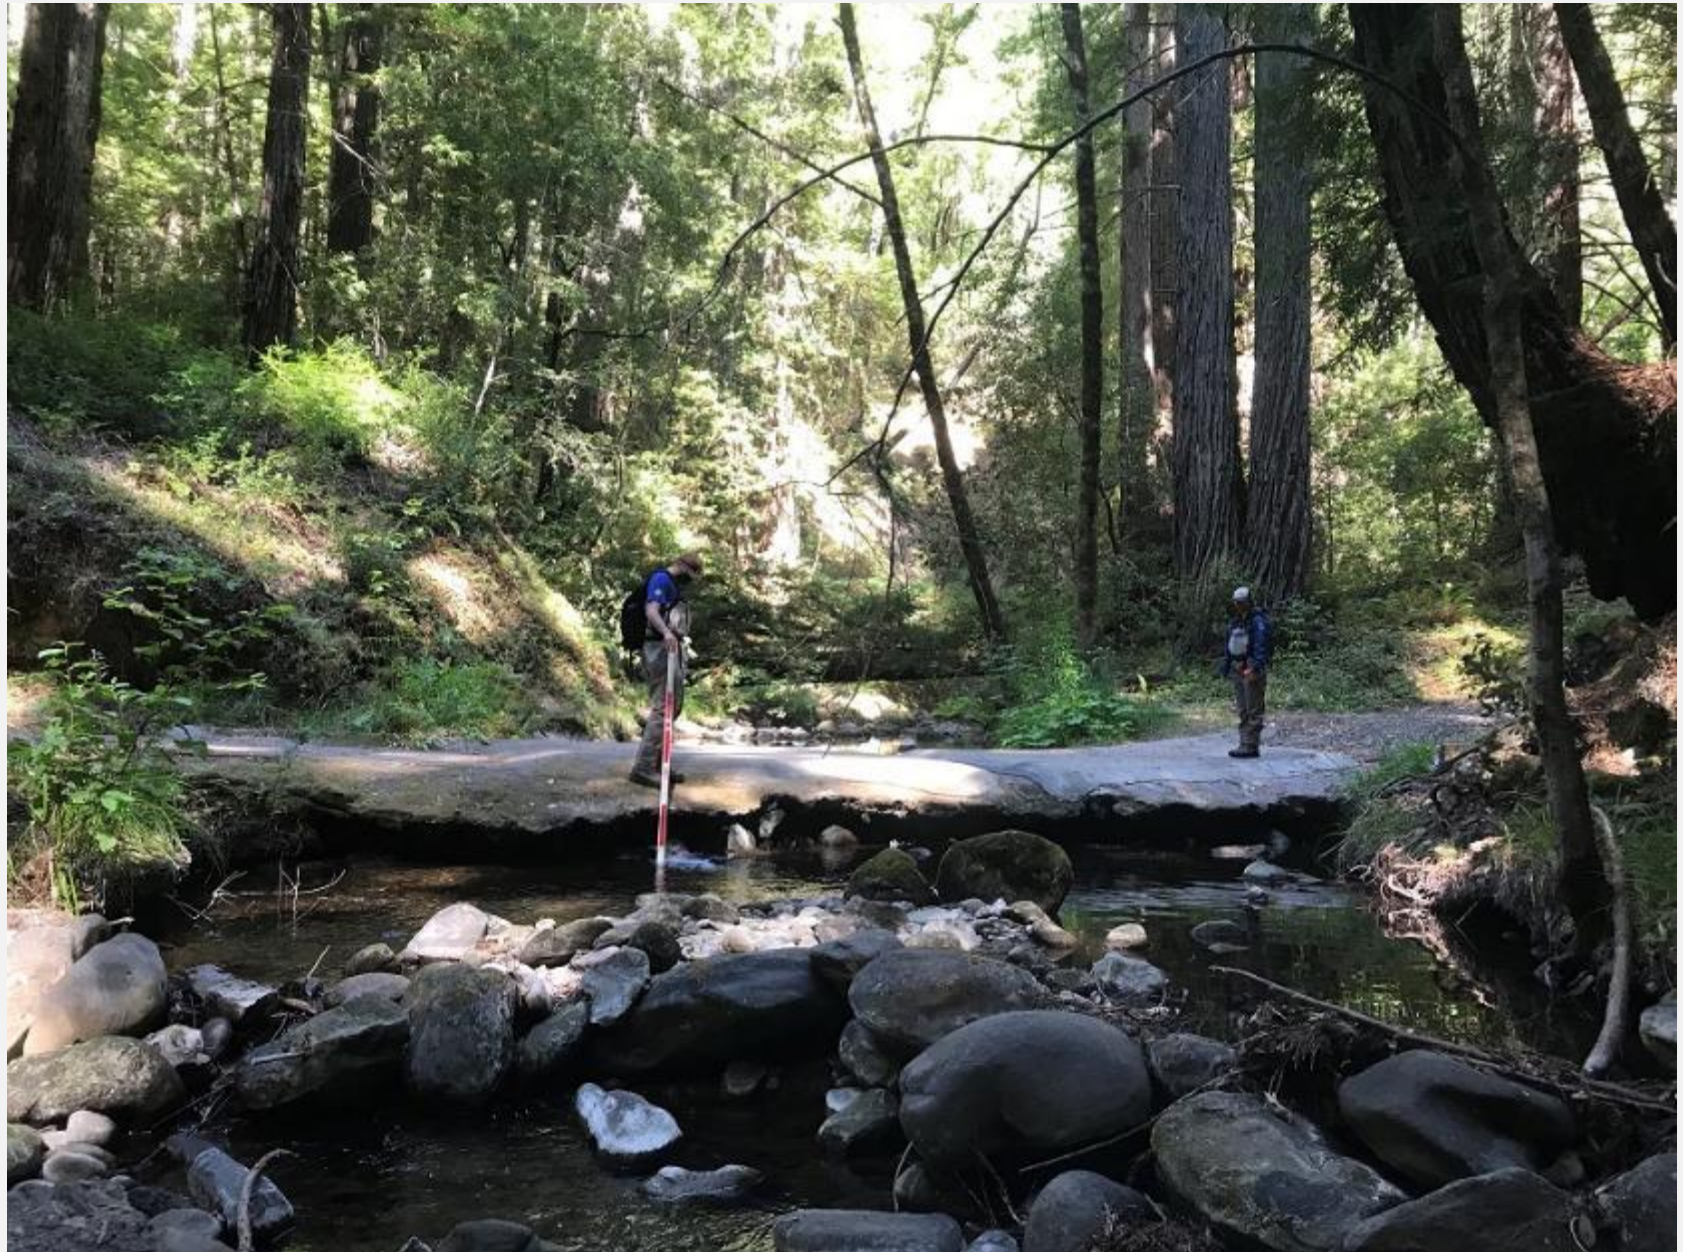
Kings Creek Truck Trail Ford

JSSH Steelhead Monitoring Program has one sampling site upstream of the Kings Creek Truck Trail ford that indicates that steelhead are able to access this upper section of the San Lorenzo River during favorable flow conditions.

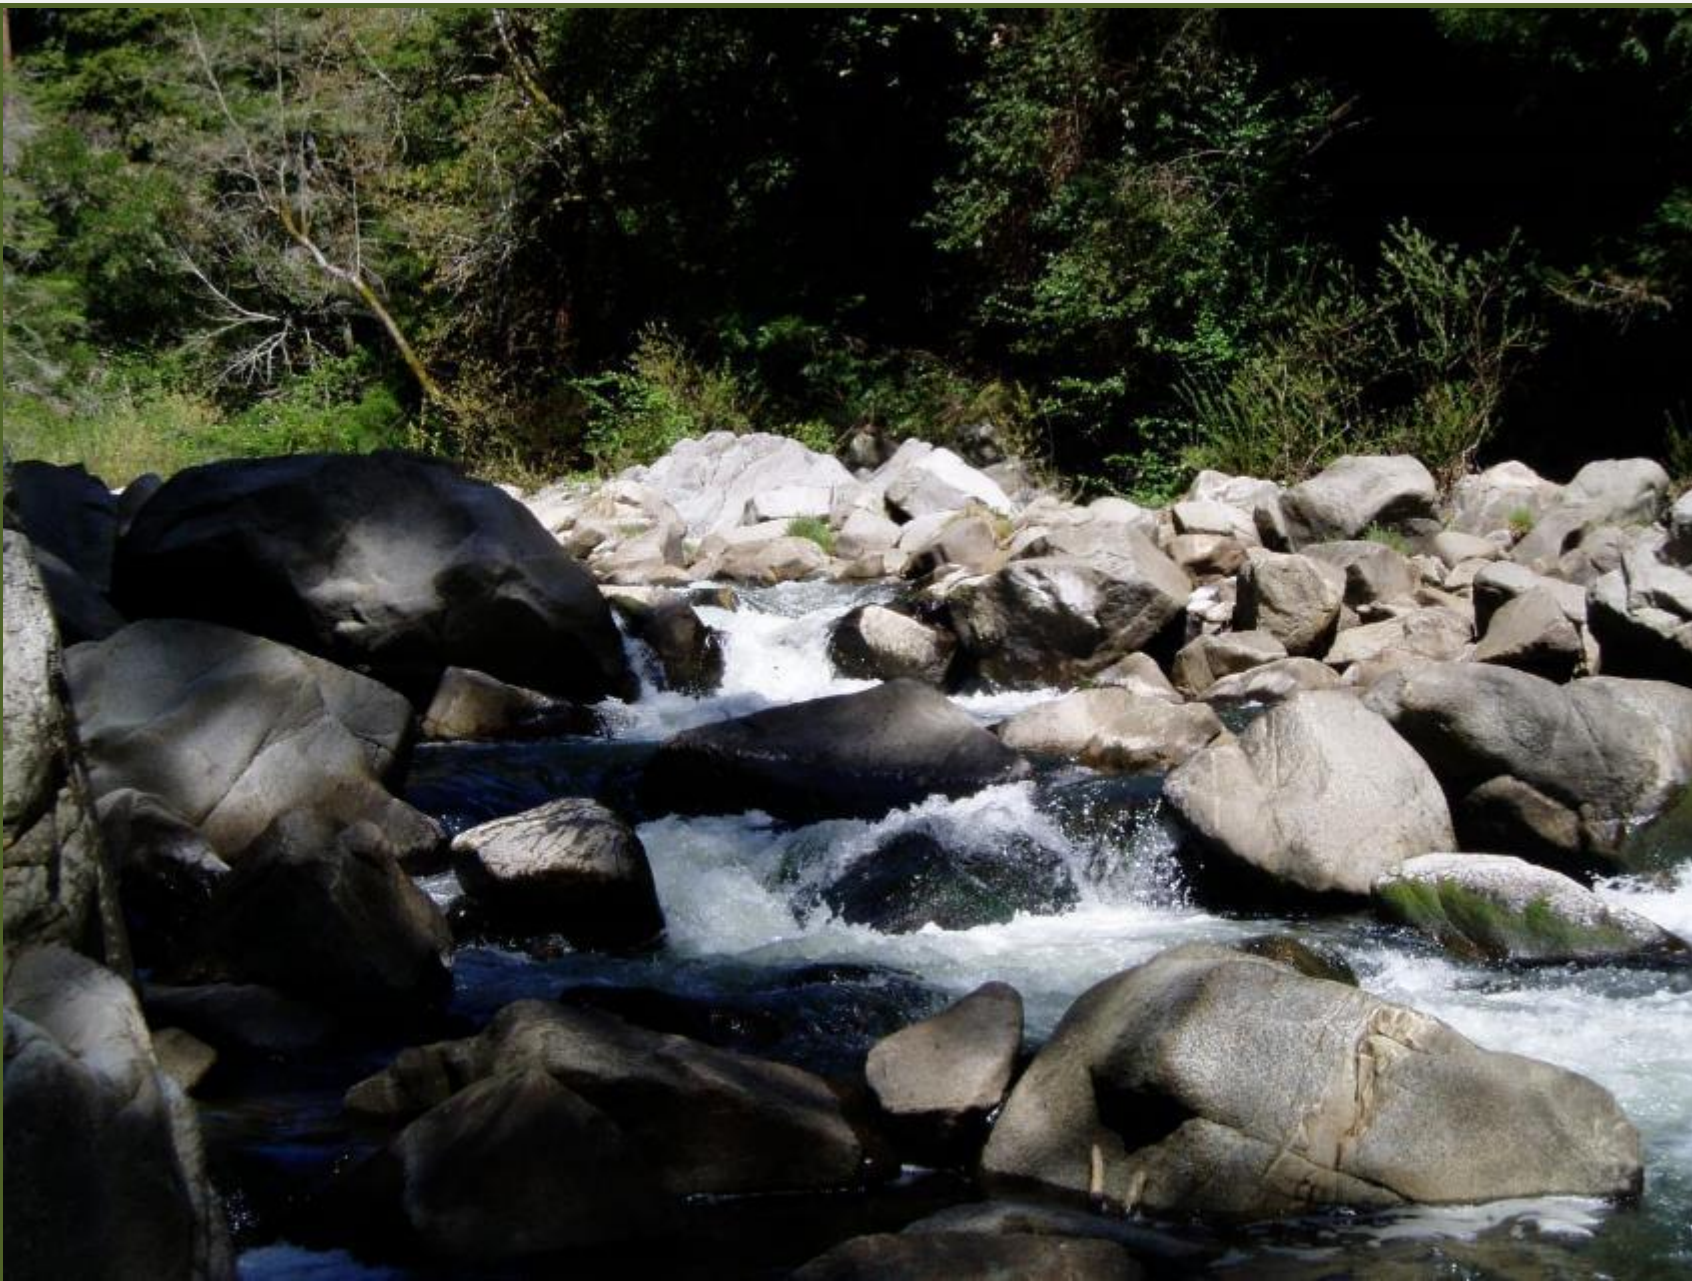
Four Rock Boulder Cascade

Four Rock Cascade is a steep boulder cascade located immediately upstream of the landmark “Four Rock”. This cascade was modified in 2008, as an IWRP project coordinated by the RCD. Initially, State Parks objected to the project since the local superintendent considered the cascade a natural feature. However, historical research showed that blasting for rail construction caused very large boulders to fall into the river at this location and, therefore, the feature was not a “natural feature” (Baldikowski, undated memo). The modification included the destruction of two key boulders in the cascade that allowed a straight leap up the most difficult portion of the cascade. While the modification improved passage, this feature is still considered a temporal barrier.

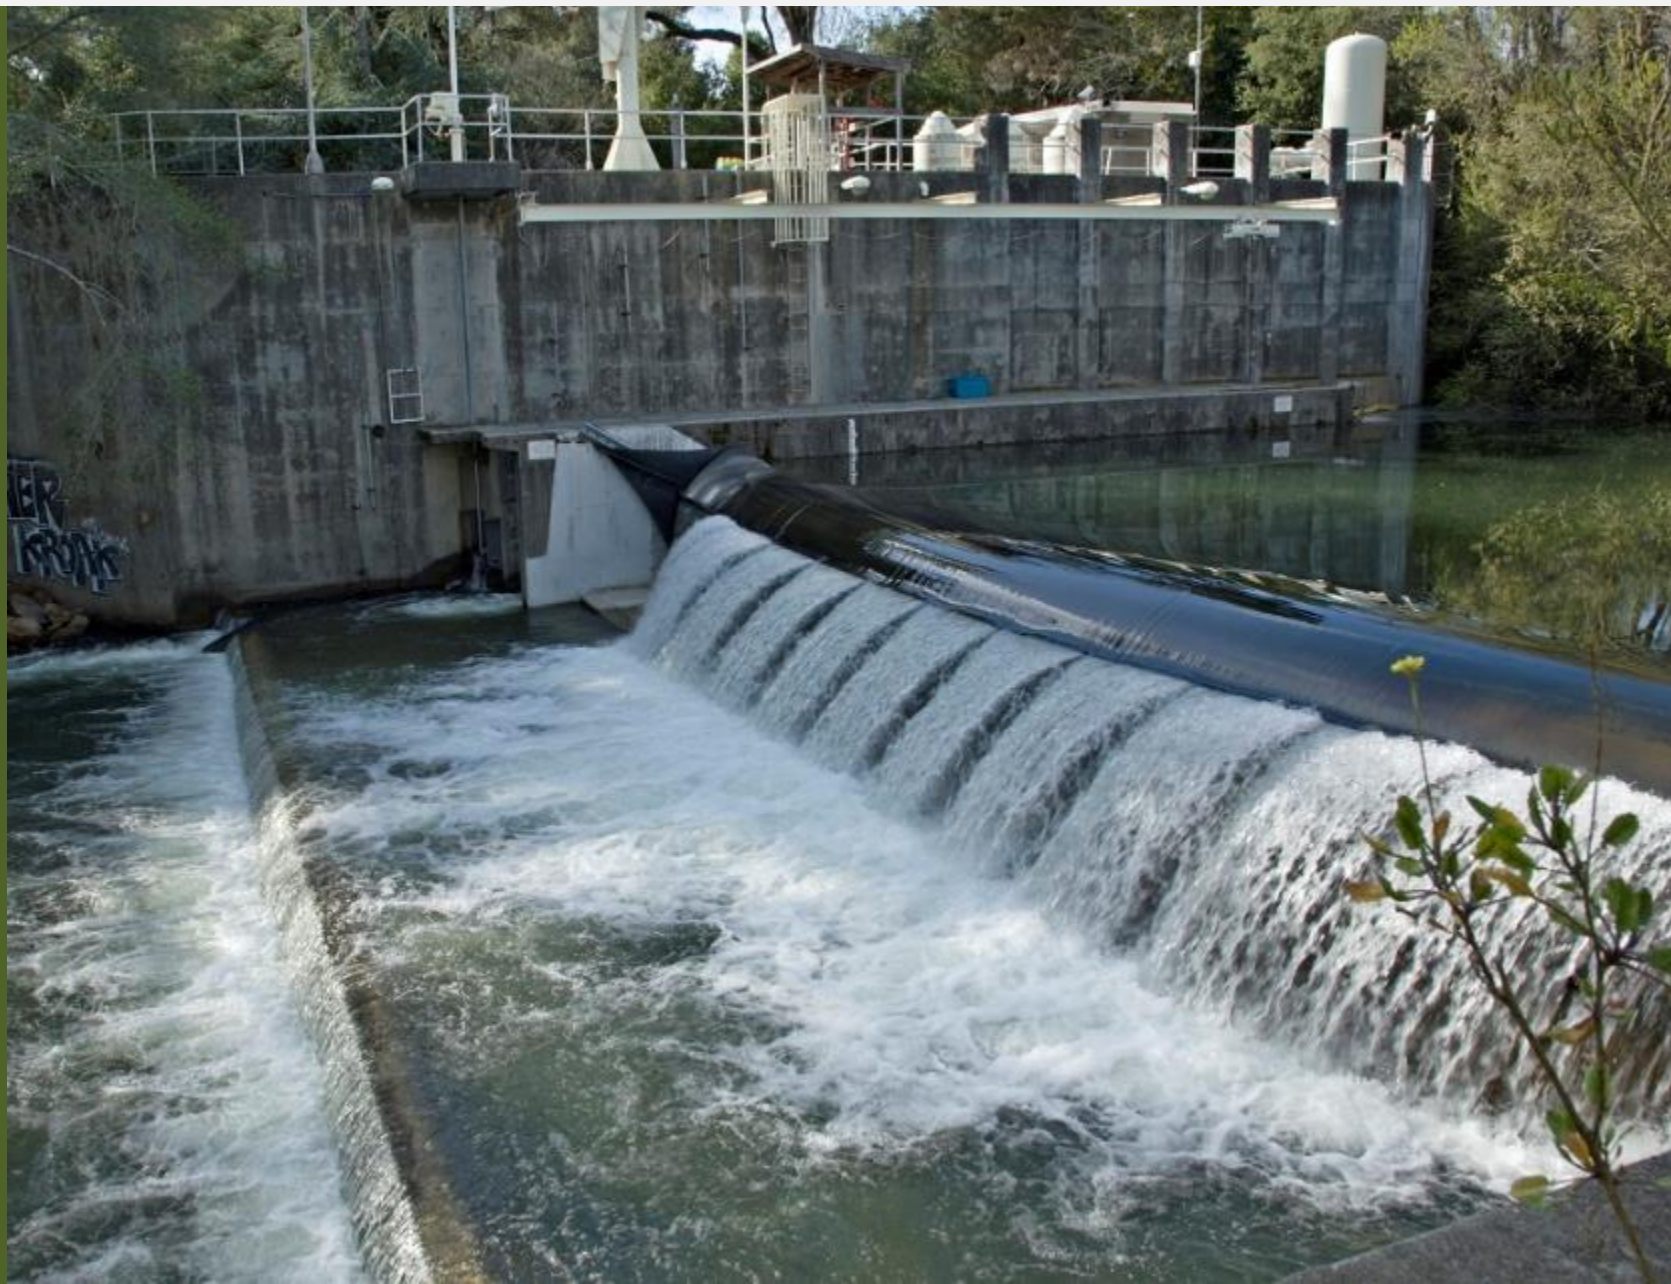
Felton Diversion – City of Santa Cruz

In the most upstream section of the Lower River, the City of Santa Cruz operates a surface water diversion at the Felton Diversion Dam that includes a channel-spanning weir with inflatable dam and fish passage facilities. The City has proposed providing a bypass flow of 40 cfs to ensure suitable passage conditions through the San Lorenzo Gorge during the migration season. The Felton Diversion Dam will be implementing passage improvements by 2035.
