# **2022 Update: County of Santa Cruz Stream Crossing Inventory and Fish Passage Evaluation**

September 12, 2022

Prepared by Kristen Kittleson, County of Santa Cruz Fishery Resource Planner  
Water Resources Program, Environmental Health, Health Services Agency

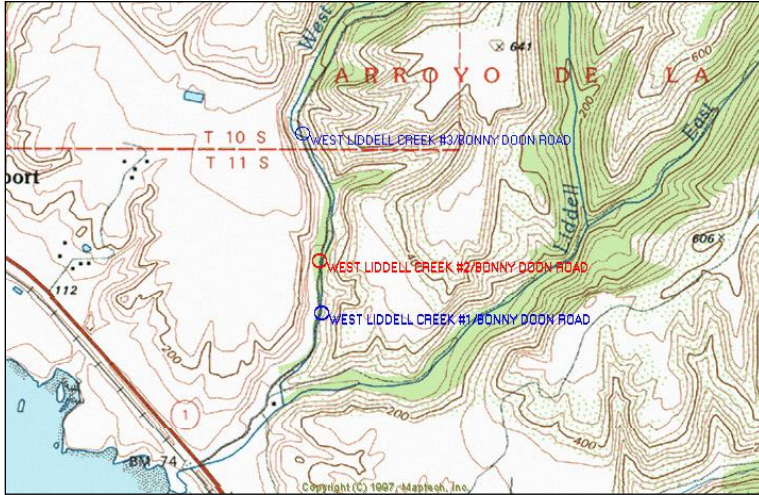
**Fill Estimate:** less than 250 cubic yards. **Overall Condition:** Extremely poor – invert rusted through. There was evidence of the culvert overtopping – with excess flow running down (and scouring) the road's inboard ditch.

**Preferred Treatment:** Because the current culvert is undersized and in very poor condition, a full replacement with a properly sized open-bottom arch or a bridge is the best solution to restore unimpeded fish migration. The new crossing should also be better aligned with the upstream channel. County of Santa

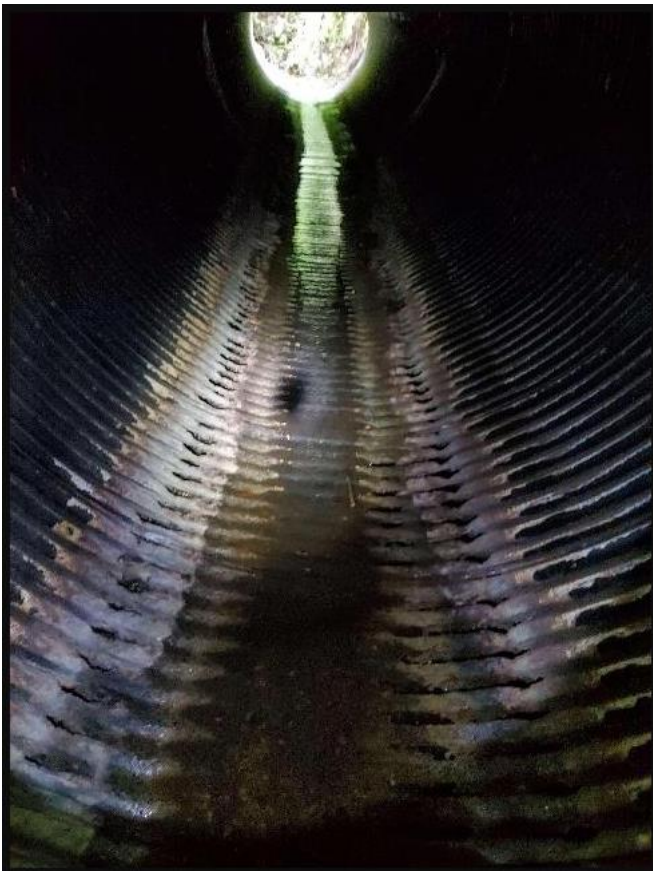
Outlet: Casserly Creek at Gaffey Road PM 0.80;  
Inside culvert, showing poor condition.

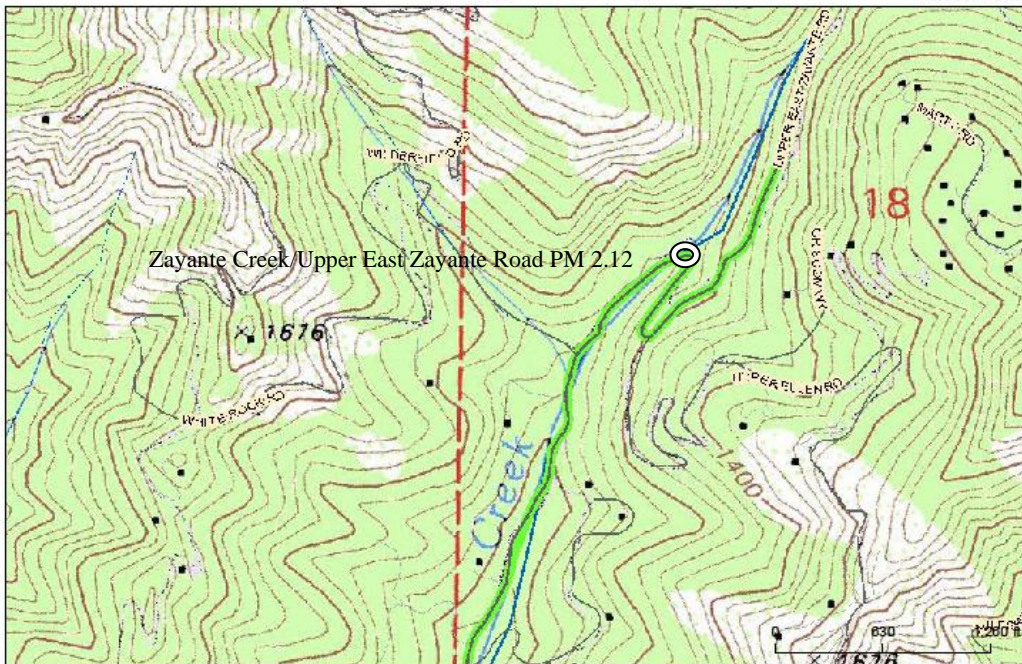
Zayante Creek at Upper East Zayante Road

This culvert crossing was not included in the 2004 report because it was considered to be upstream of the extent of anadromy. Fieldwork from 2013 confirm that this culvert is upstream of several significant partial passage barriers and is most likely upstream of the extent of anadromy. However, *O. mykiss*, most likely resident steelhead, were found immediately downstream of this culvert indicating that the culvert could be considered the most upstream extent of anadromy on Zayante Creek. Upstream of the culvert, Zayante Creek has low flows and three additional passage barriers within 300'. The area upstream of the culvert is functioning as a Pacific Giant Salamander nursery area. USFWS supports maintaining this culvert barrier to protect this nursery area (J. Martin, personal communication).

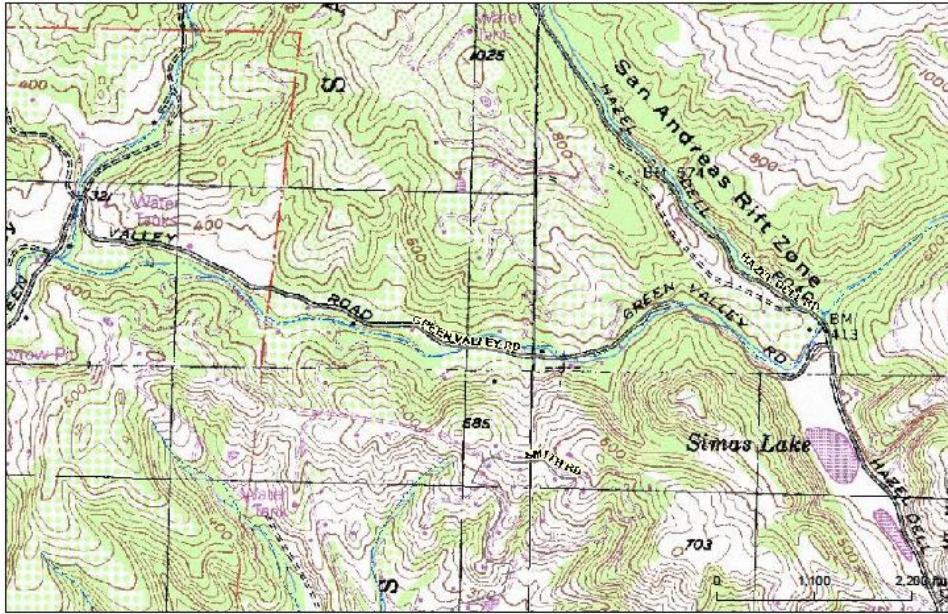
Green Valley PM 0.38

This culvert crossing was not included in the 2004 report because the previous culvert was storm damaged and there was no stream crossing during the 2002 fieldwork. In 2003, a new 9' culvert was installed. Natural substrate is found throughout the culvert. Rip rap at the inlet creates a 1' jump. On June 4, 2015, young-of-the-year *O. mykiss*, most likely resident steelhead, were observed upstream and downstream of the culvert. A larger resident fish was observed in a pool downstream of the culvert. A project to modify the rip rap could be implemented but should

consider upstream passage conditions in Green Valley Creek.
