Inventory of Historical Structures and Anadromous Fish Passage Conditions in the San Lorenzo River, Santa Cruz County, California

Final Report
November 8, 2023

Prepared by the County of Santa Cruz Water Resources Program,
Environmental Health, Health Services Agency

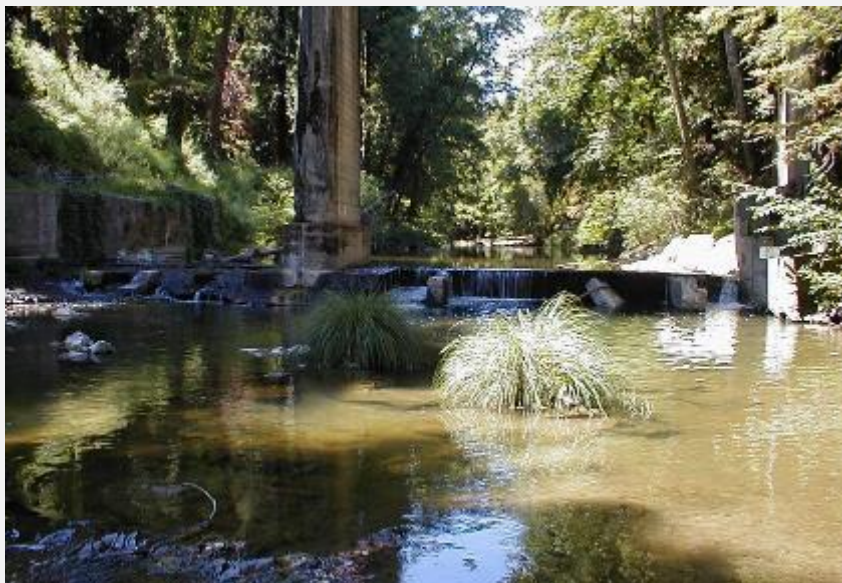
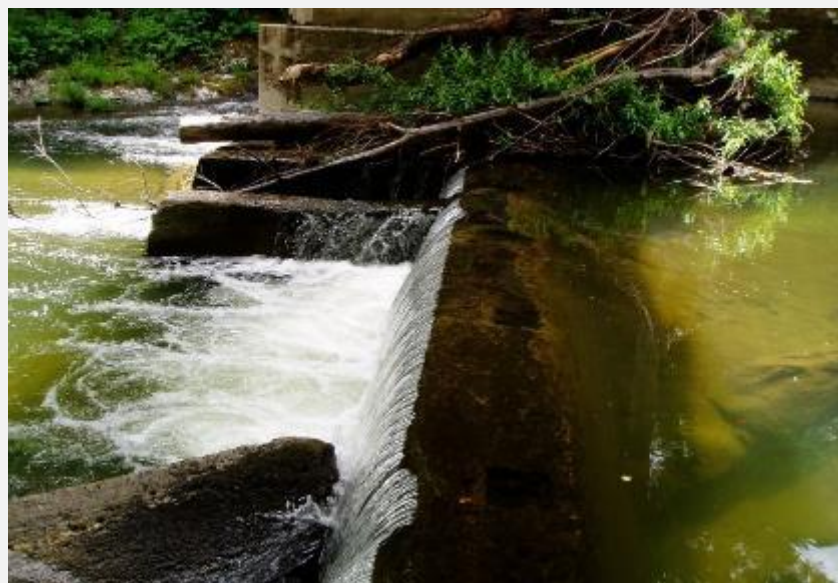
Bridge Foundation PAD ID# 706926 - High Passage Severity

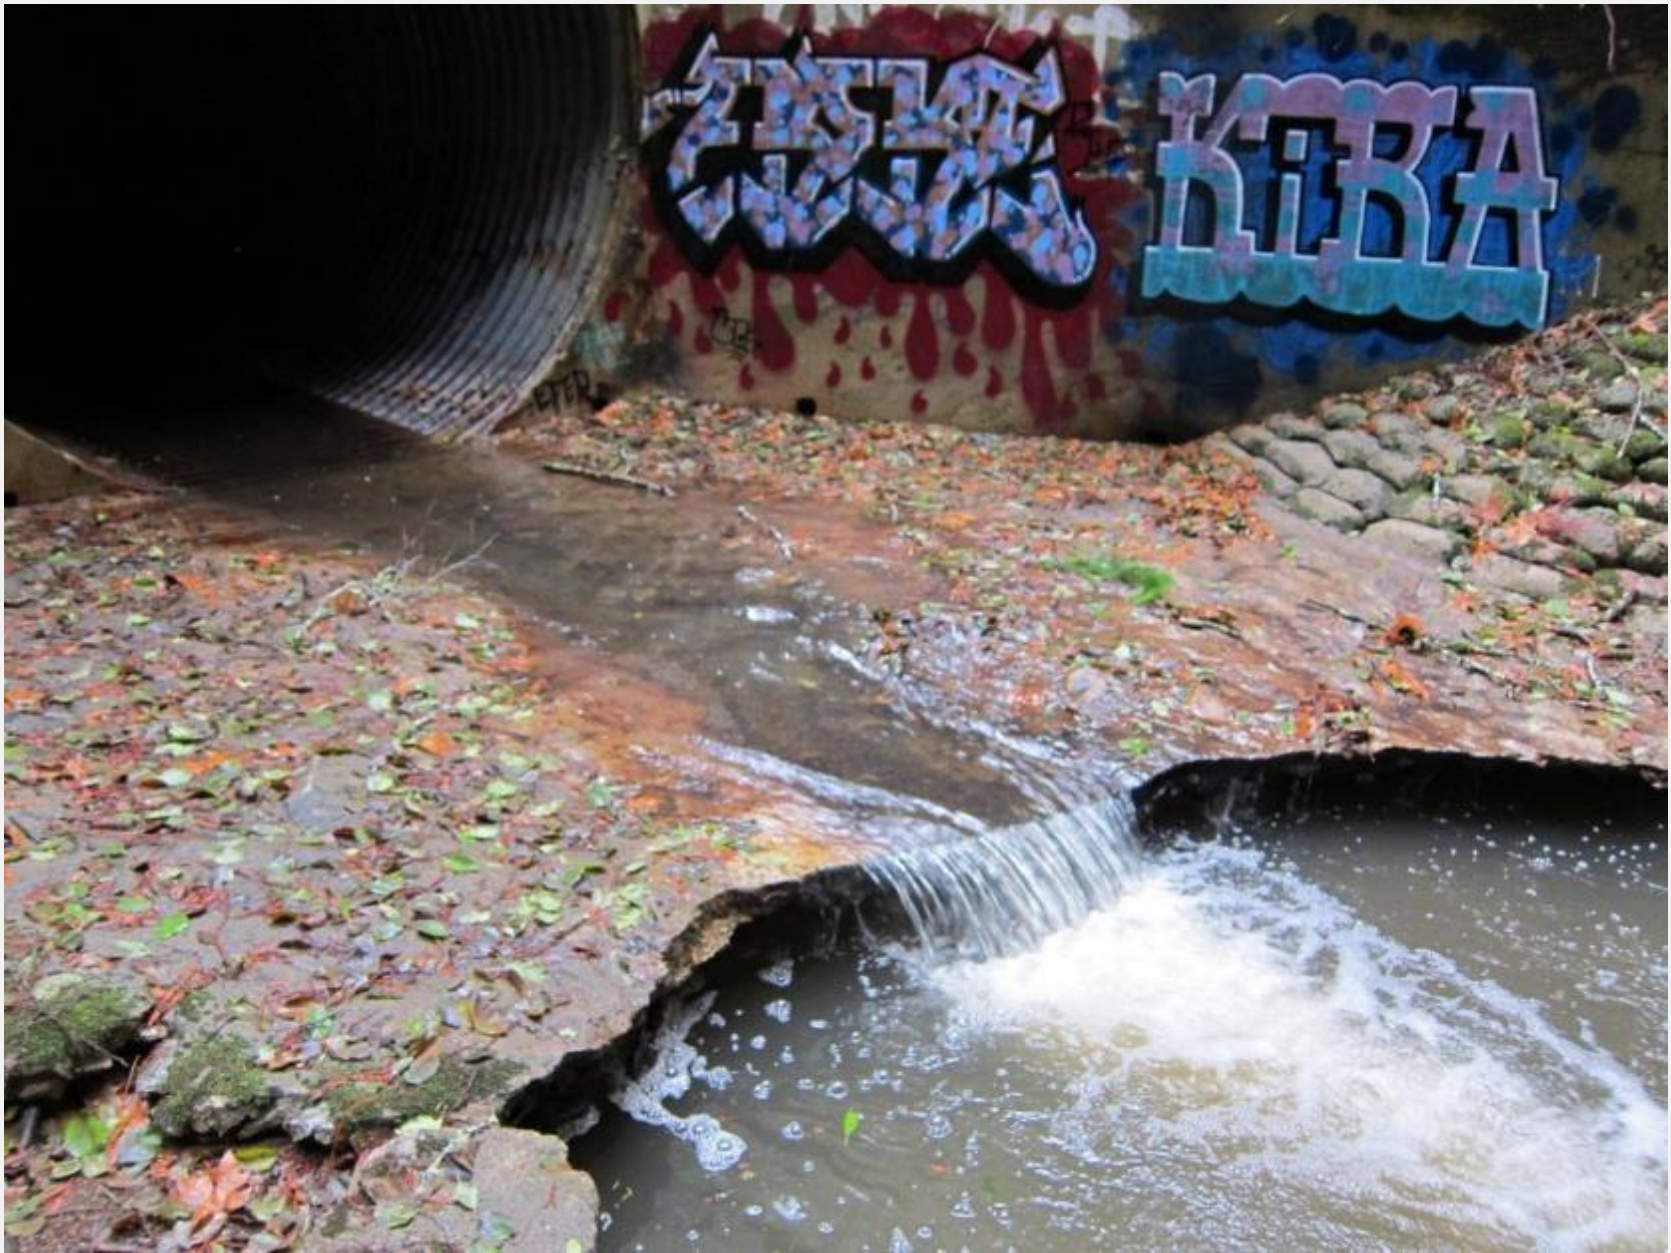
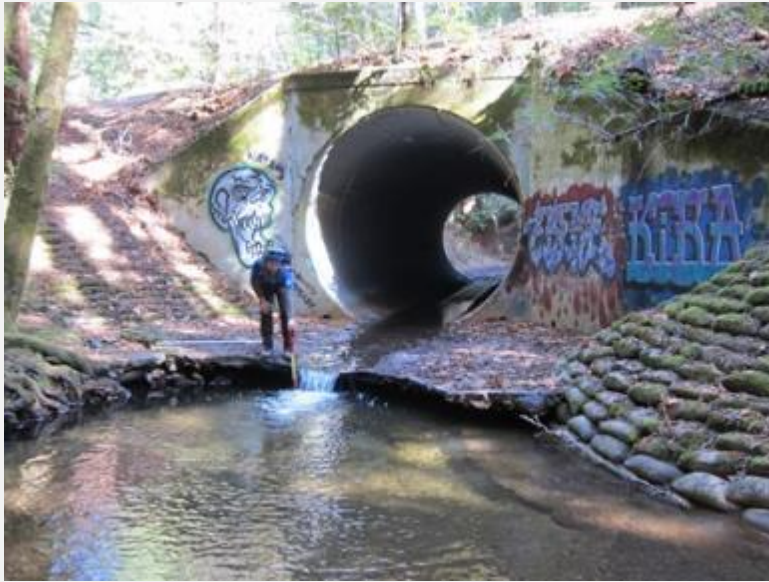
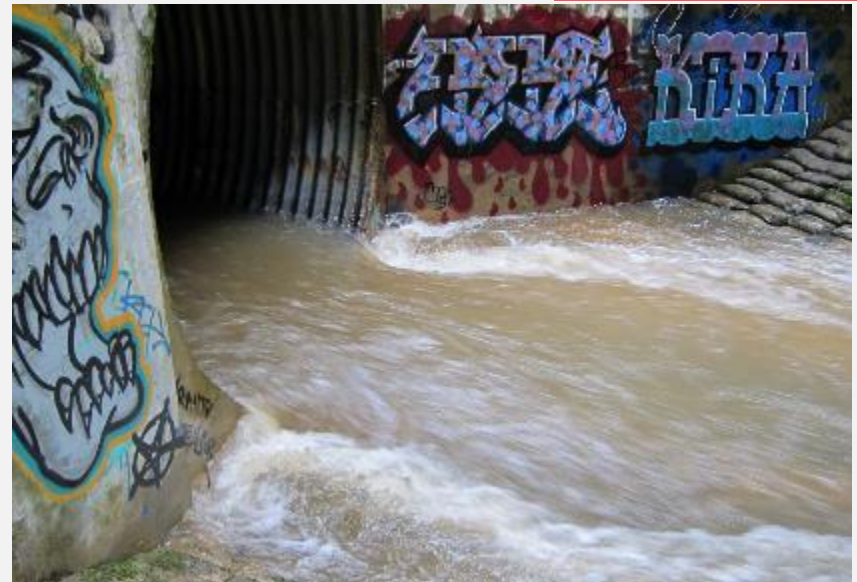
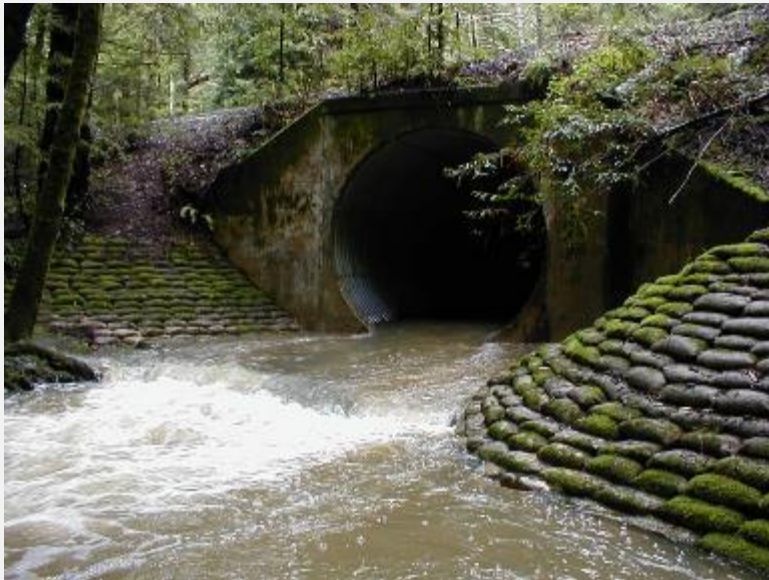
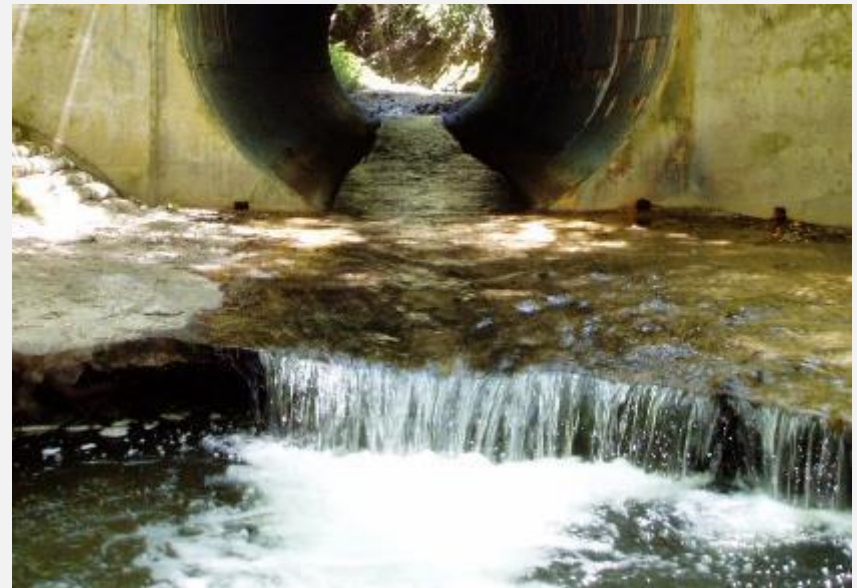
Highway 9 Waterman Gap

Severity: HIGH

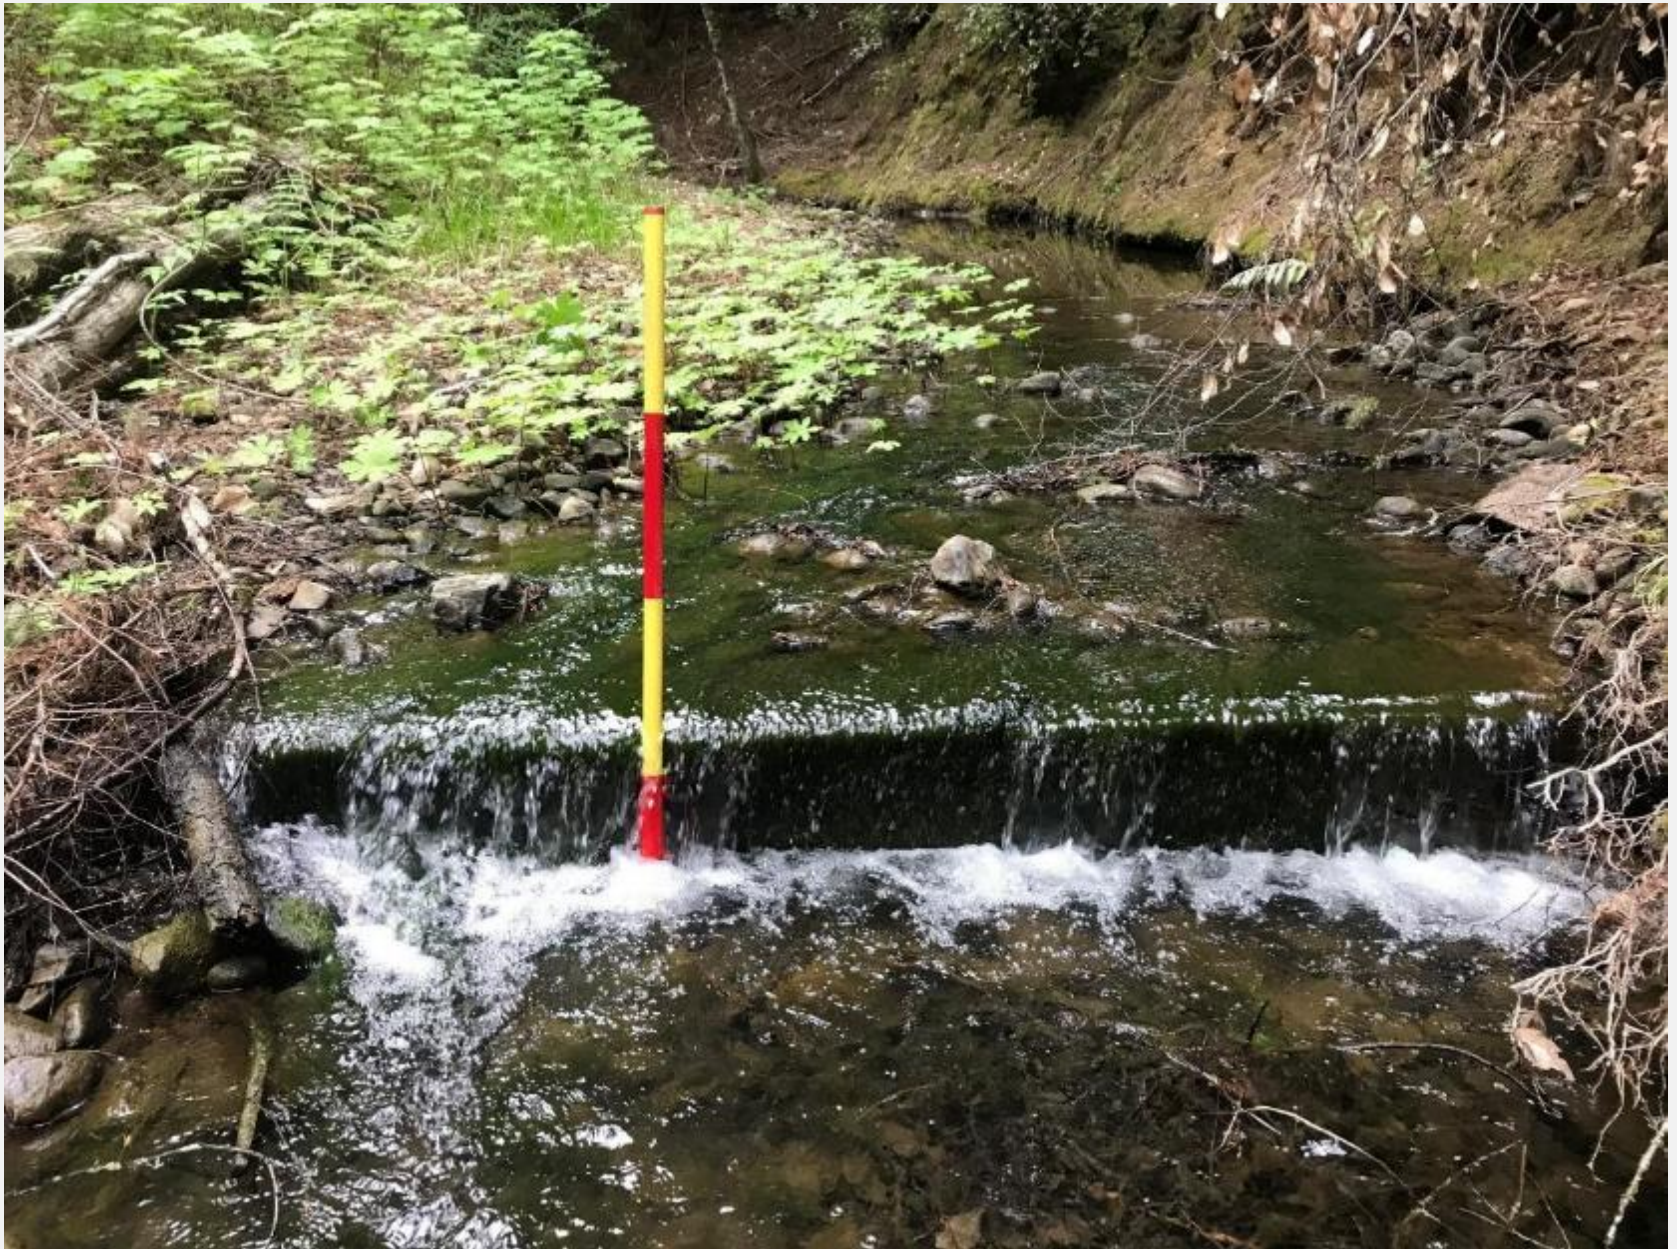
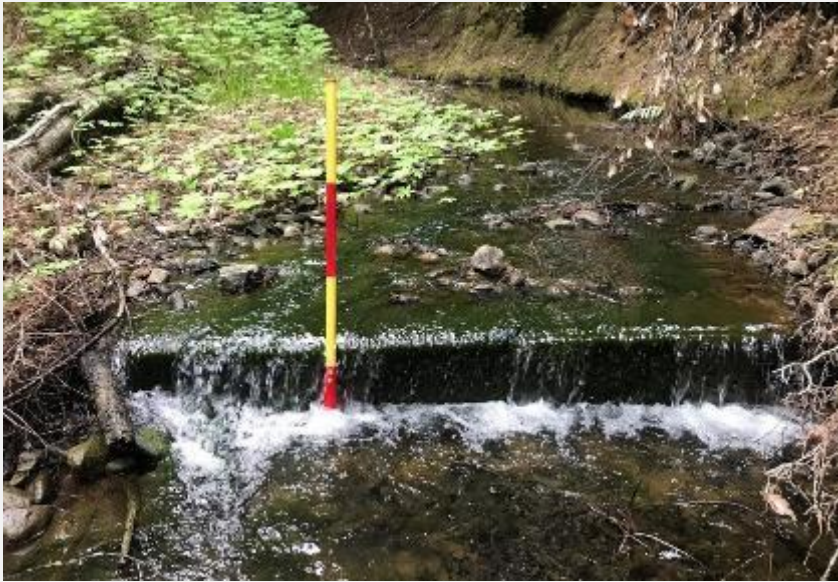
Historical Gage Weir

There is a concrete weir for an inactive stream gage immediately upstream (20 feet) of the Highway 9 crossing. The structure is 1-foot high and does not have a jump pool downstream, which adds difficulty to passage at the Highway 9 crossing. This small structure can easily be removed concurrently with the replacement of the Highway 9 culvert. In 2023, sediment deposition upstream of the culvert crossing has temporarily buried the structure.

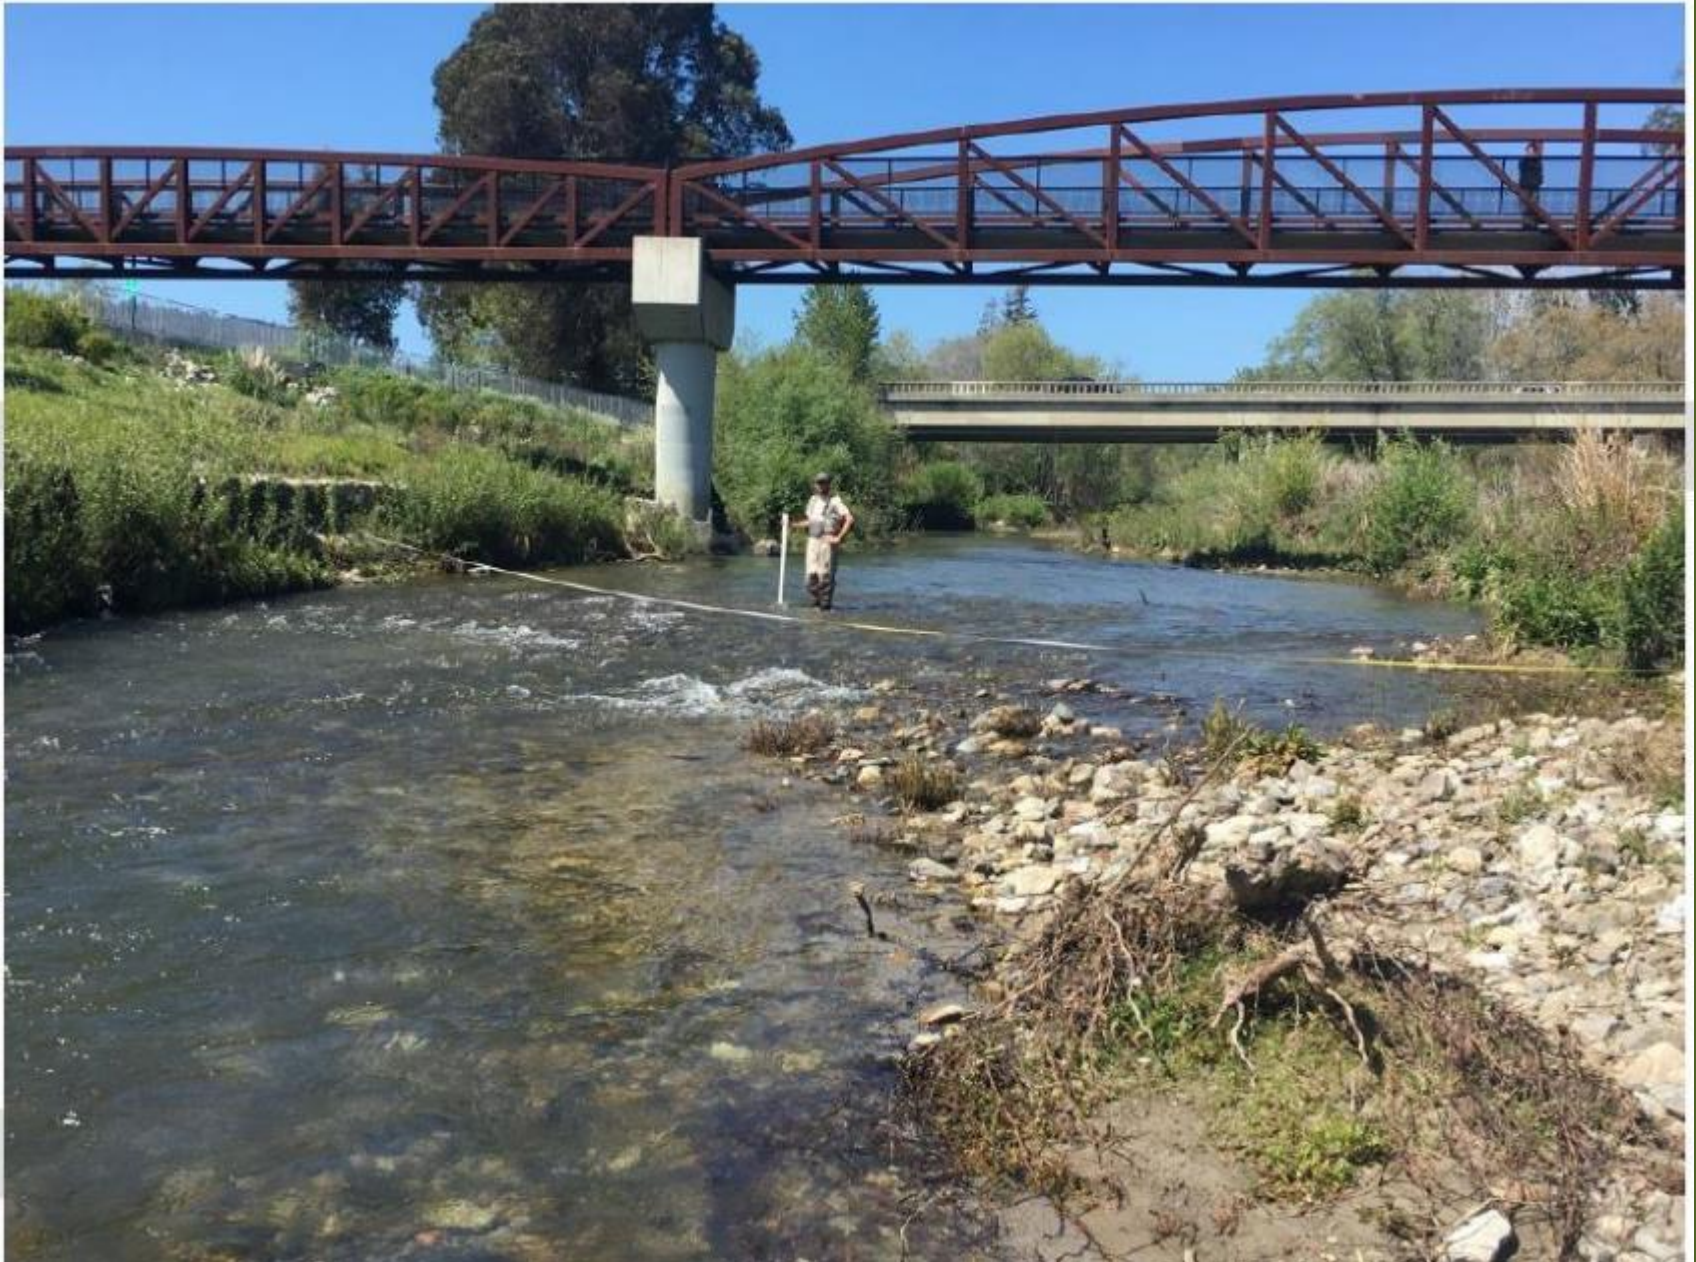
Critical Riffle #1

Severity: NONE

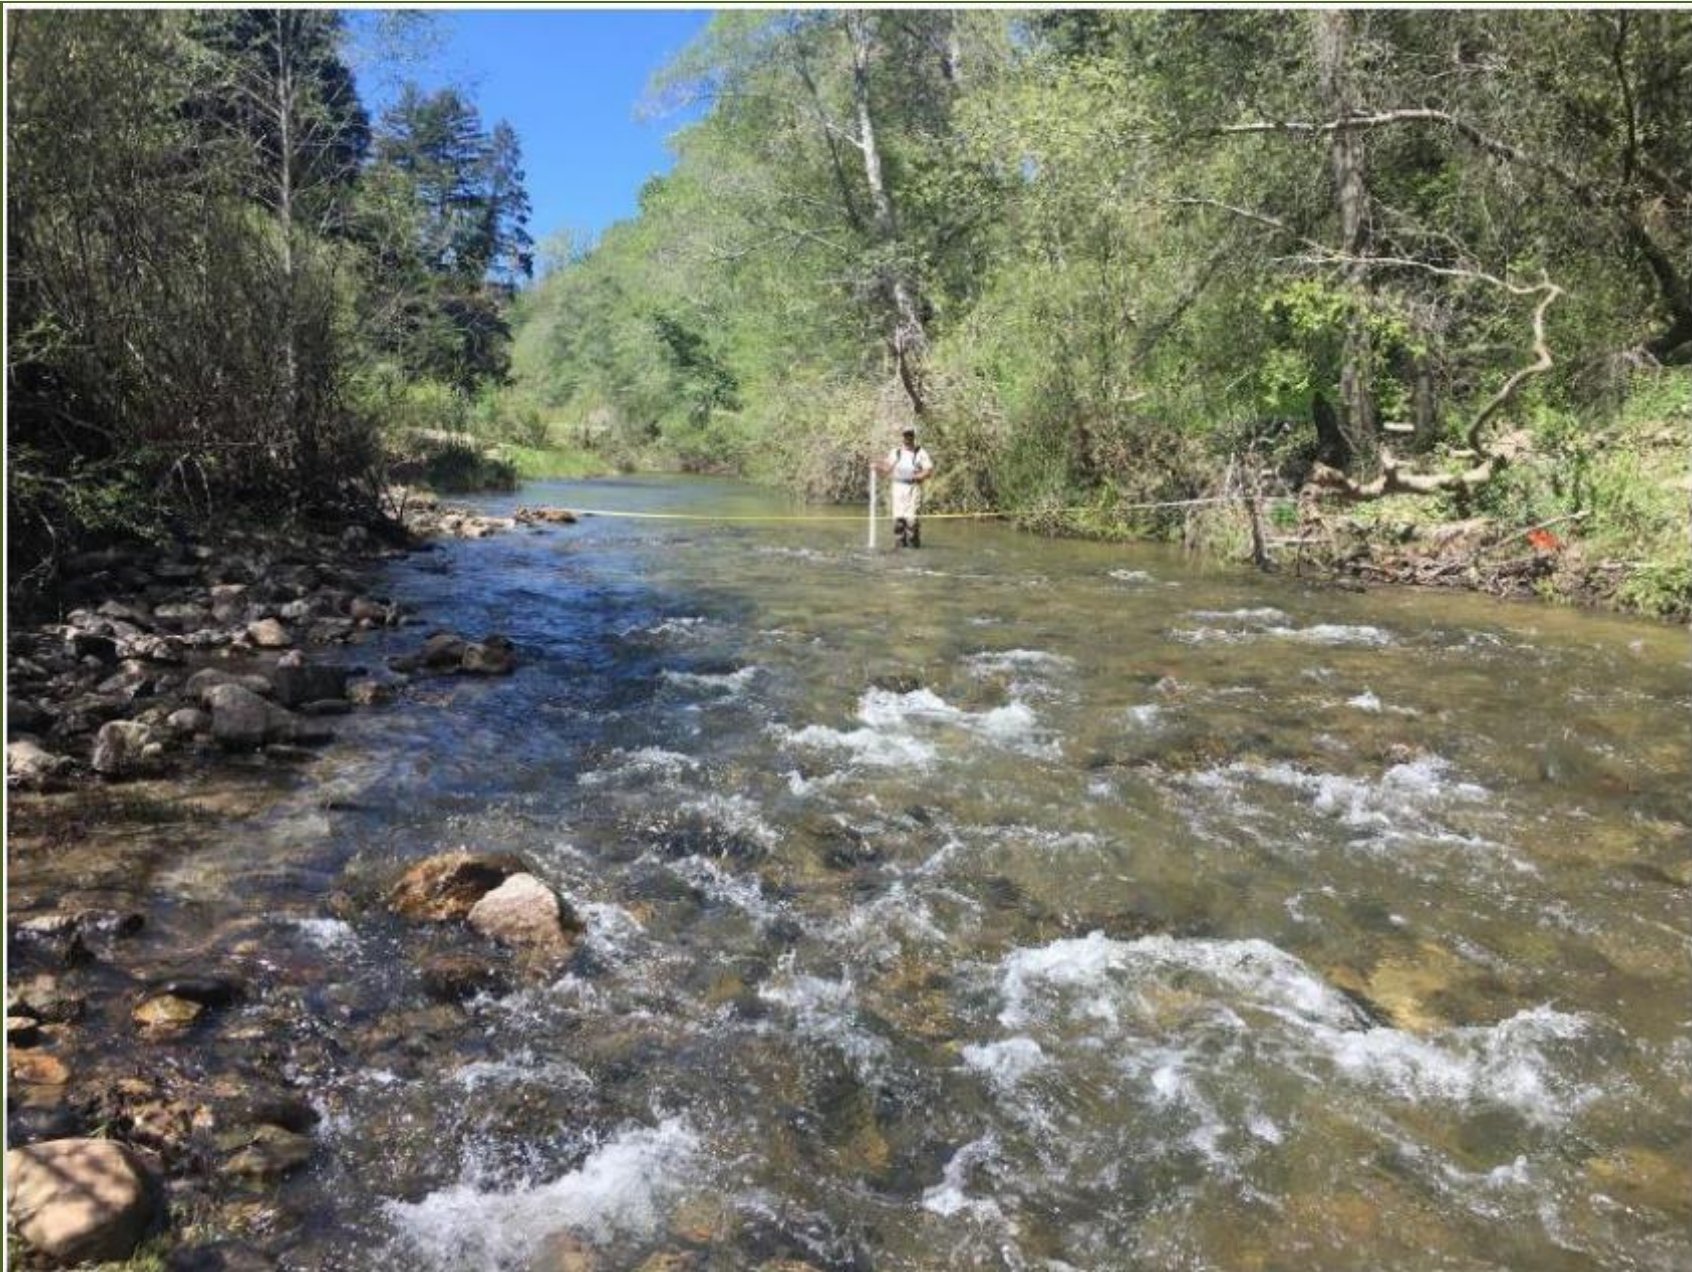
Critical Riffle #2

Severity: LOW

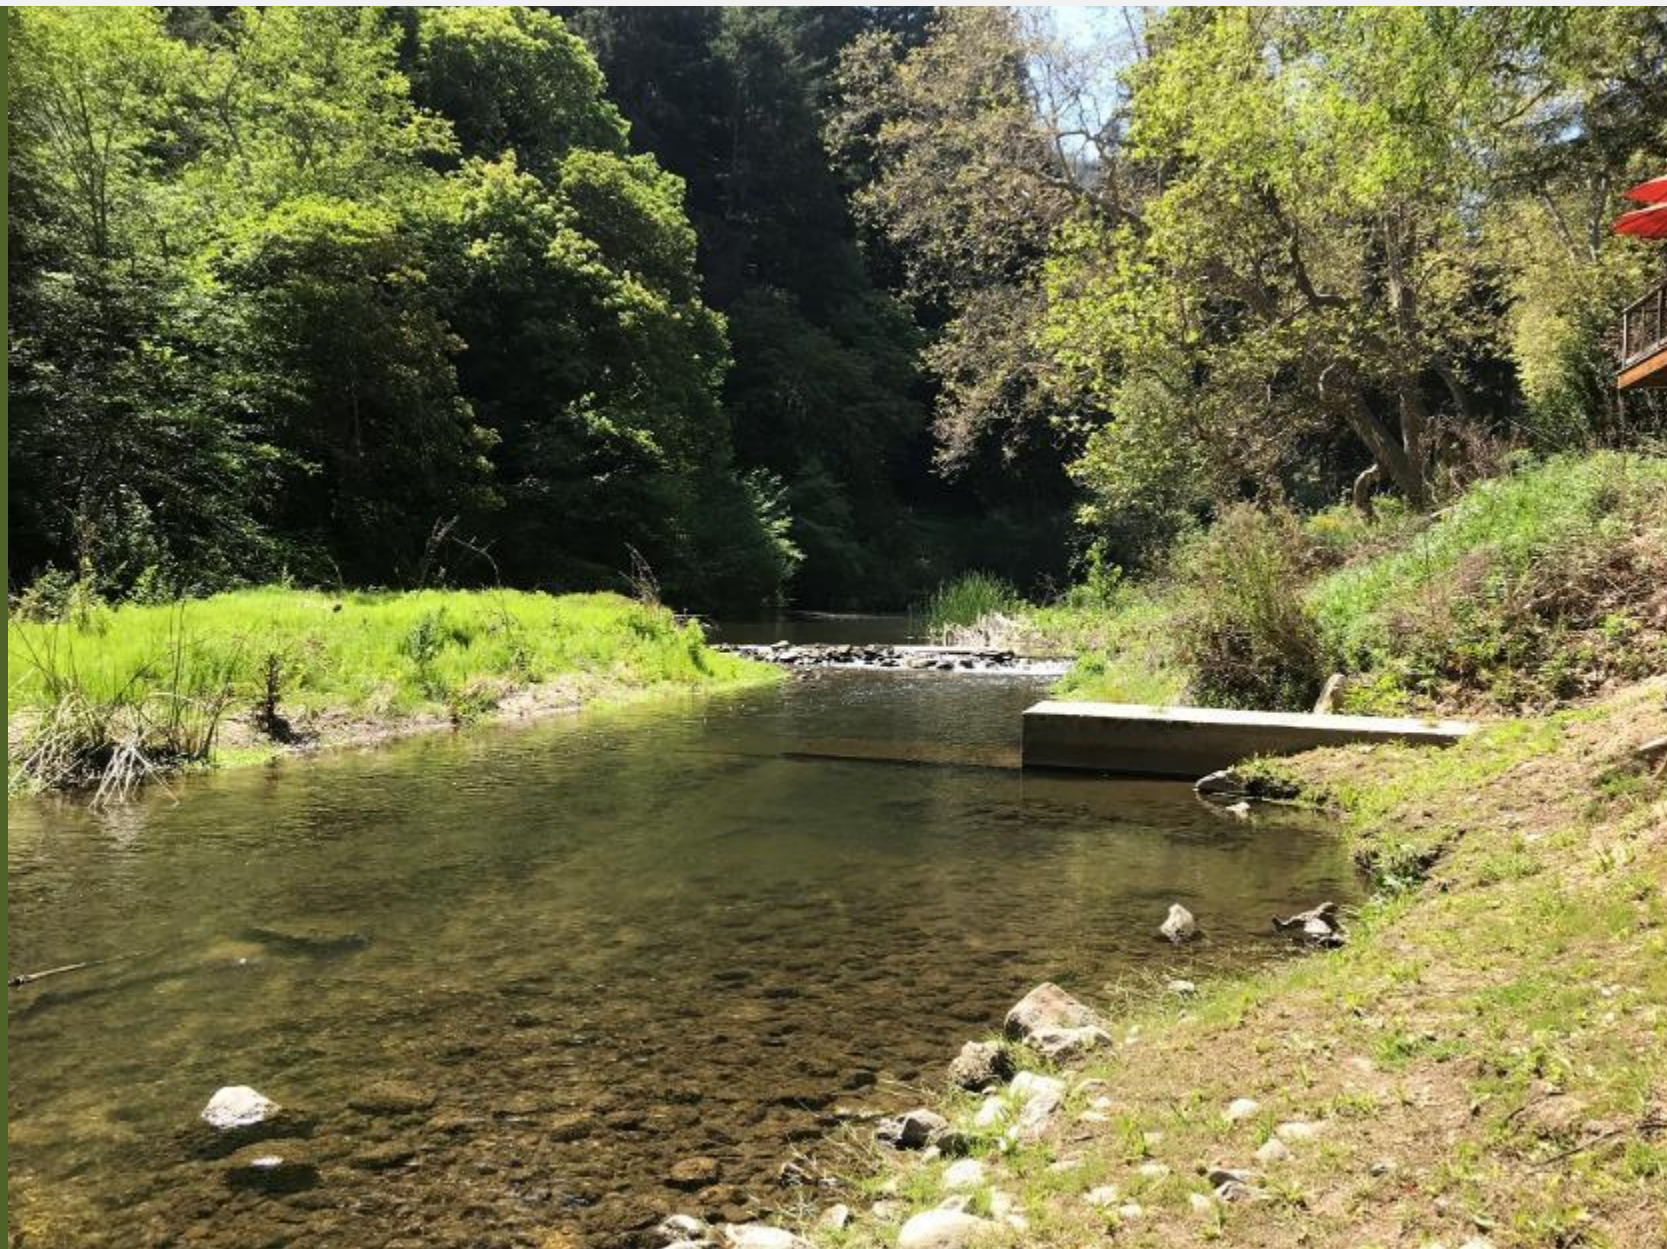
Paradise Park Historical Dam Structure

Severity: NONE

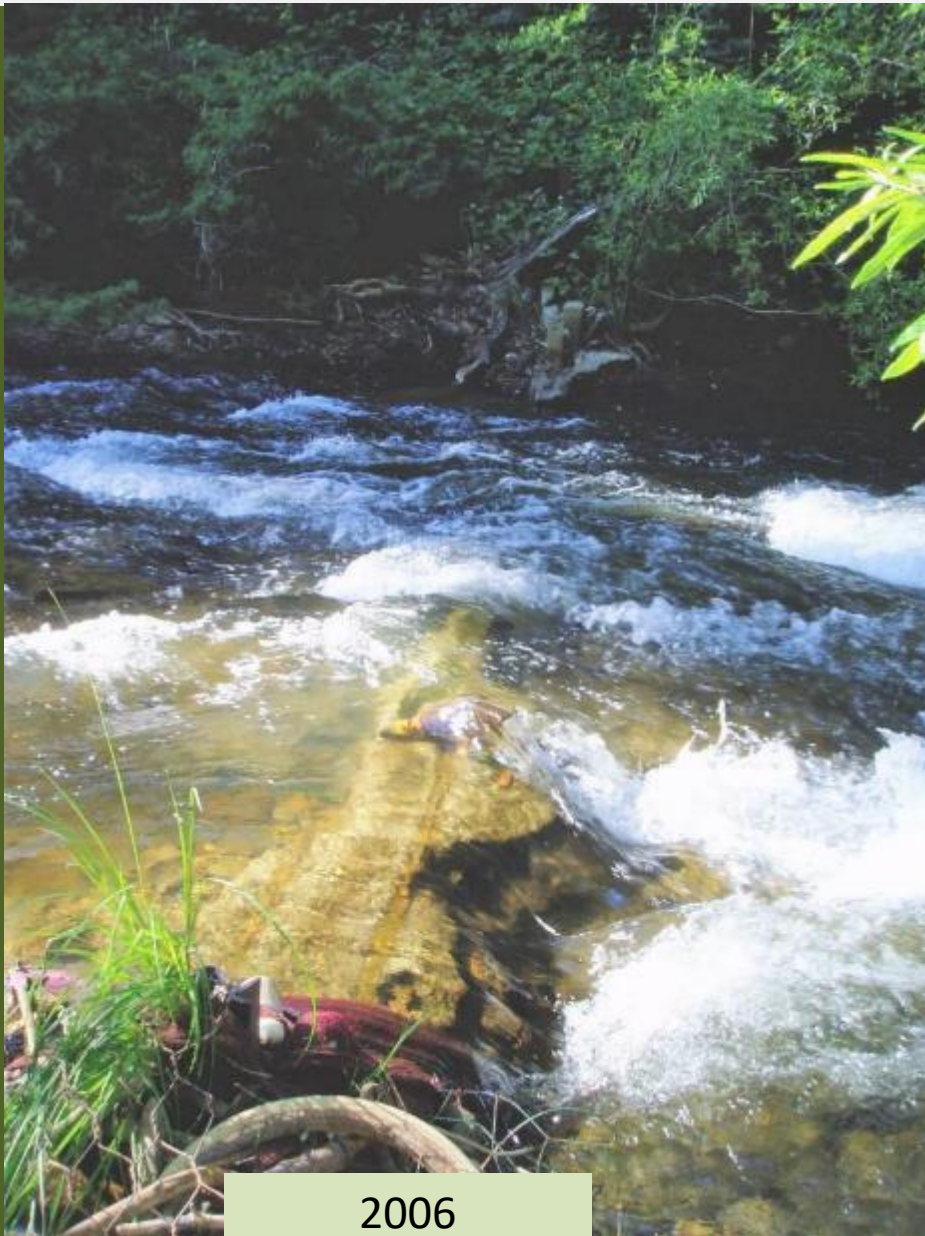
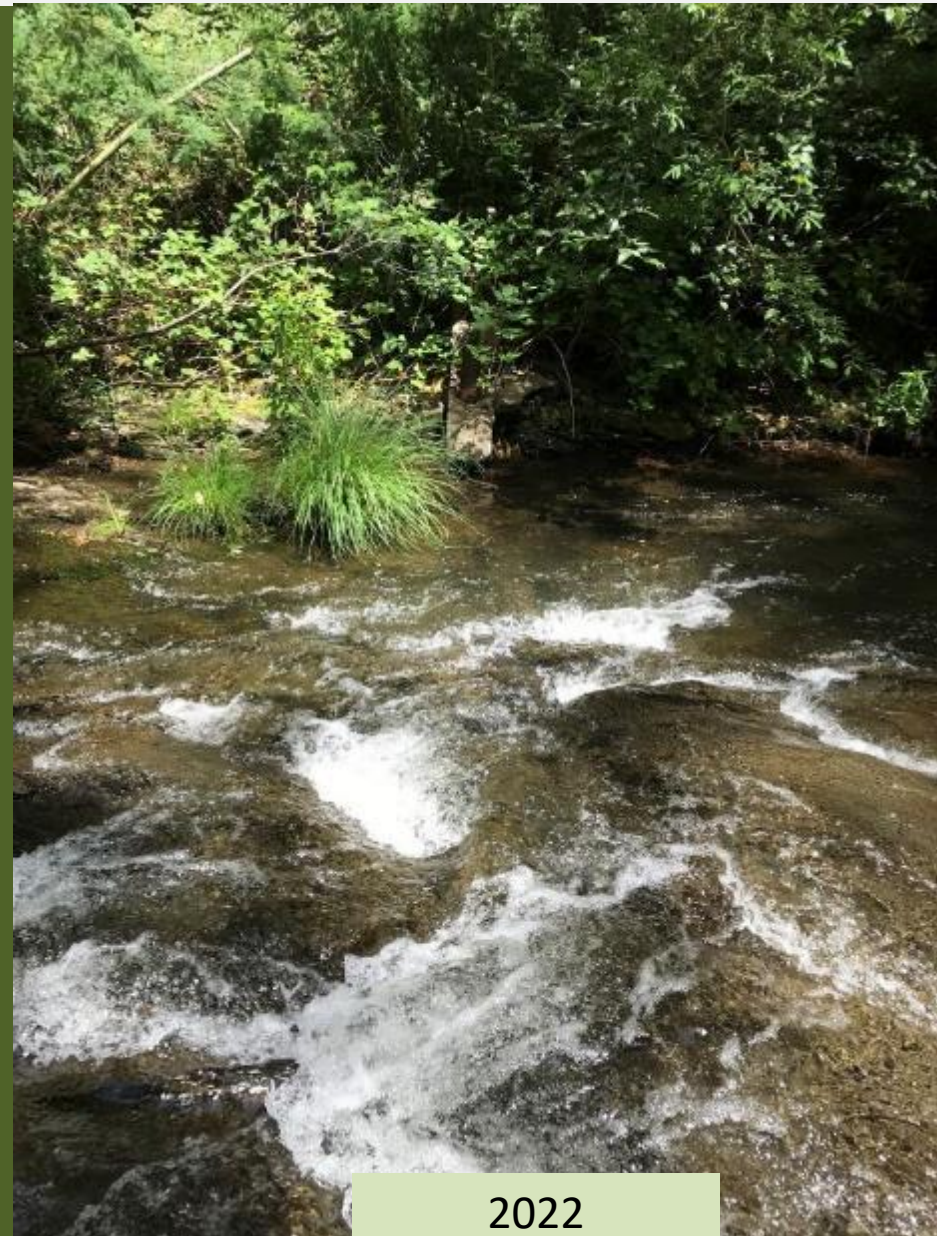
Highlands Historical Dam Remnant

Severity: NONE

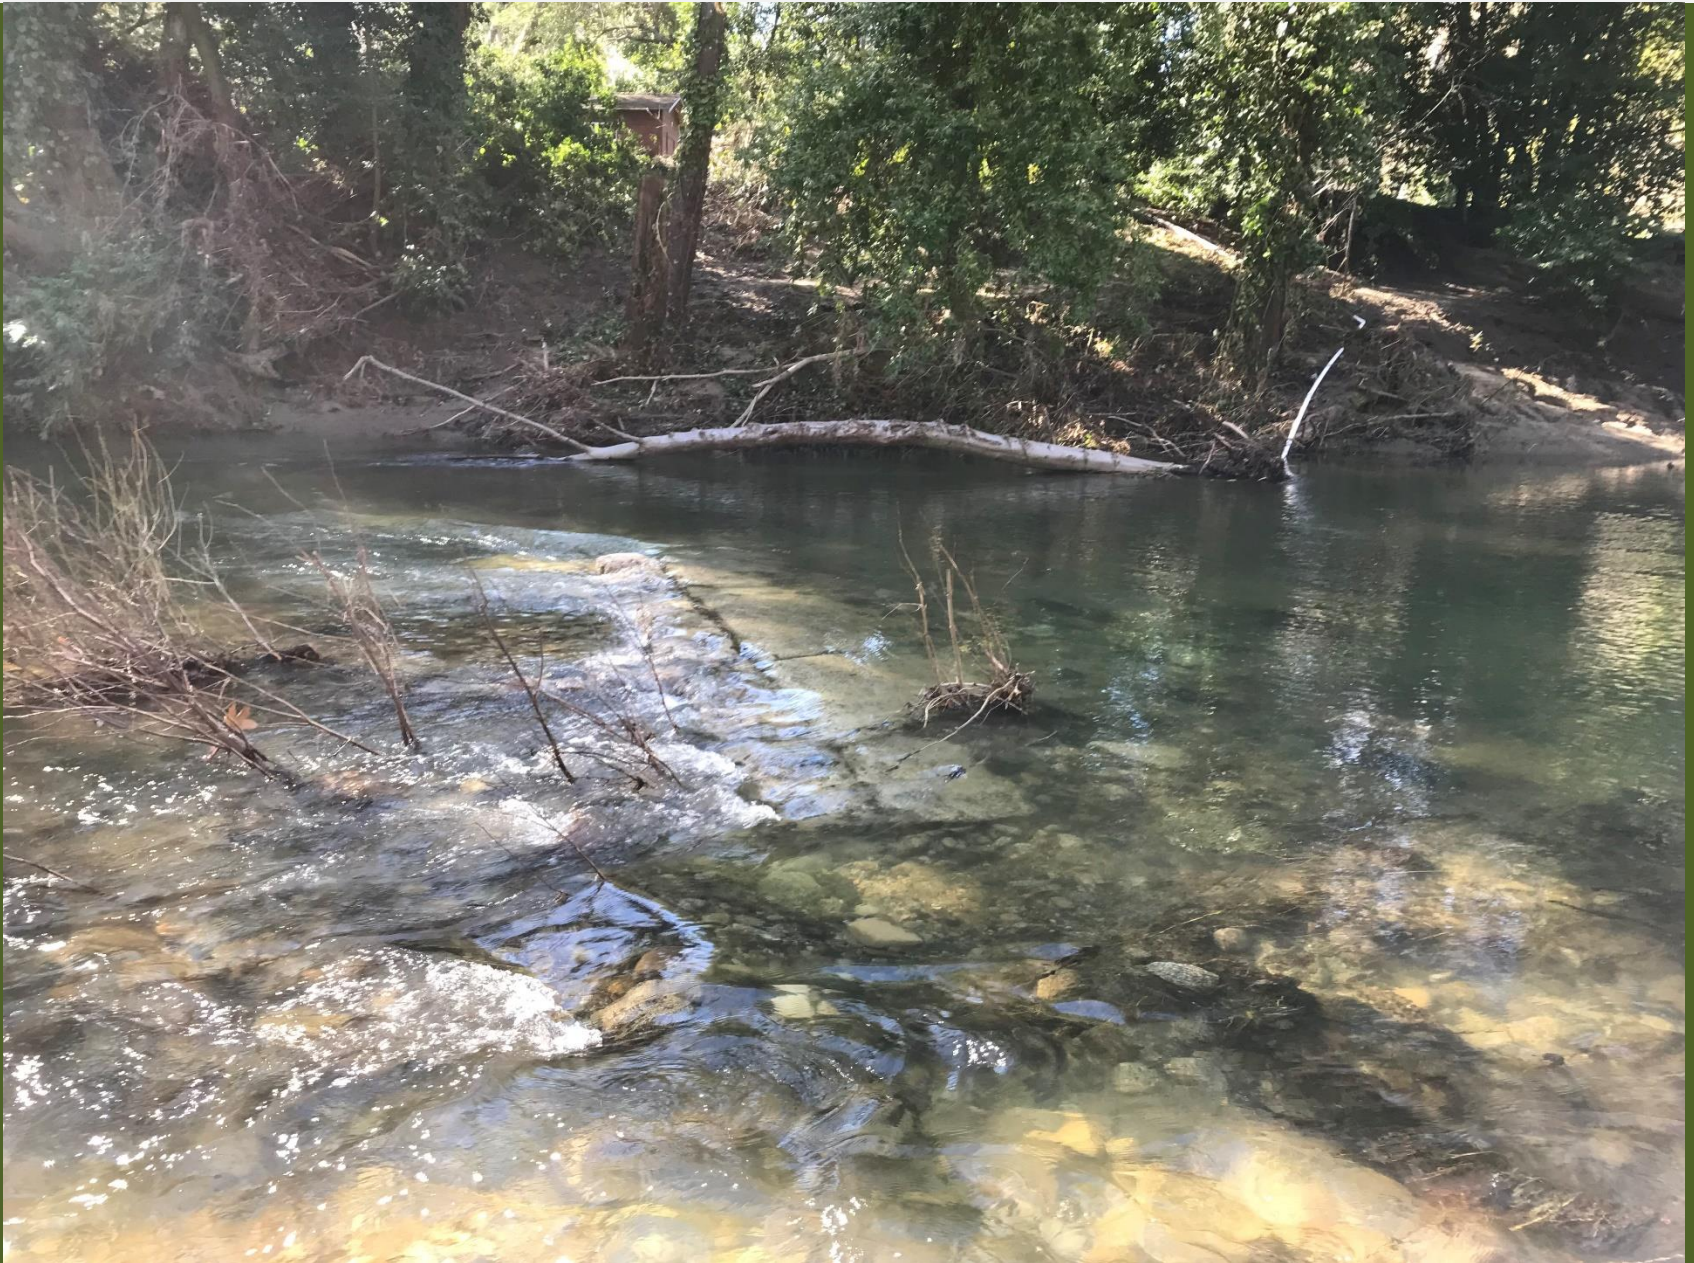
Ben Lomond Historical Dam Remnant

Severity: MEDIUM

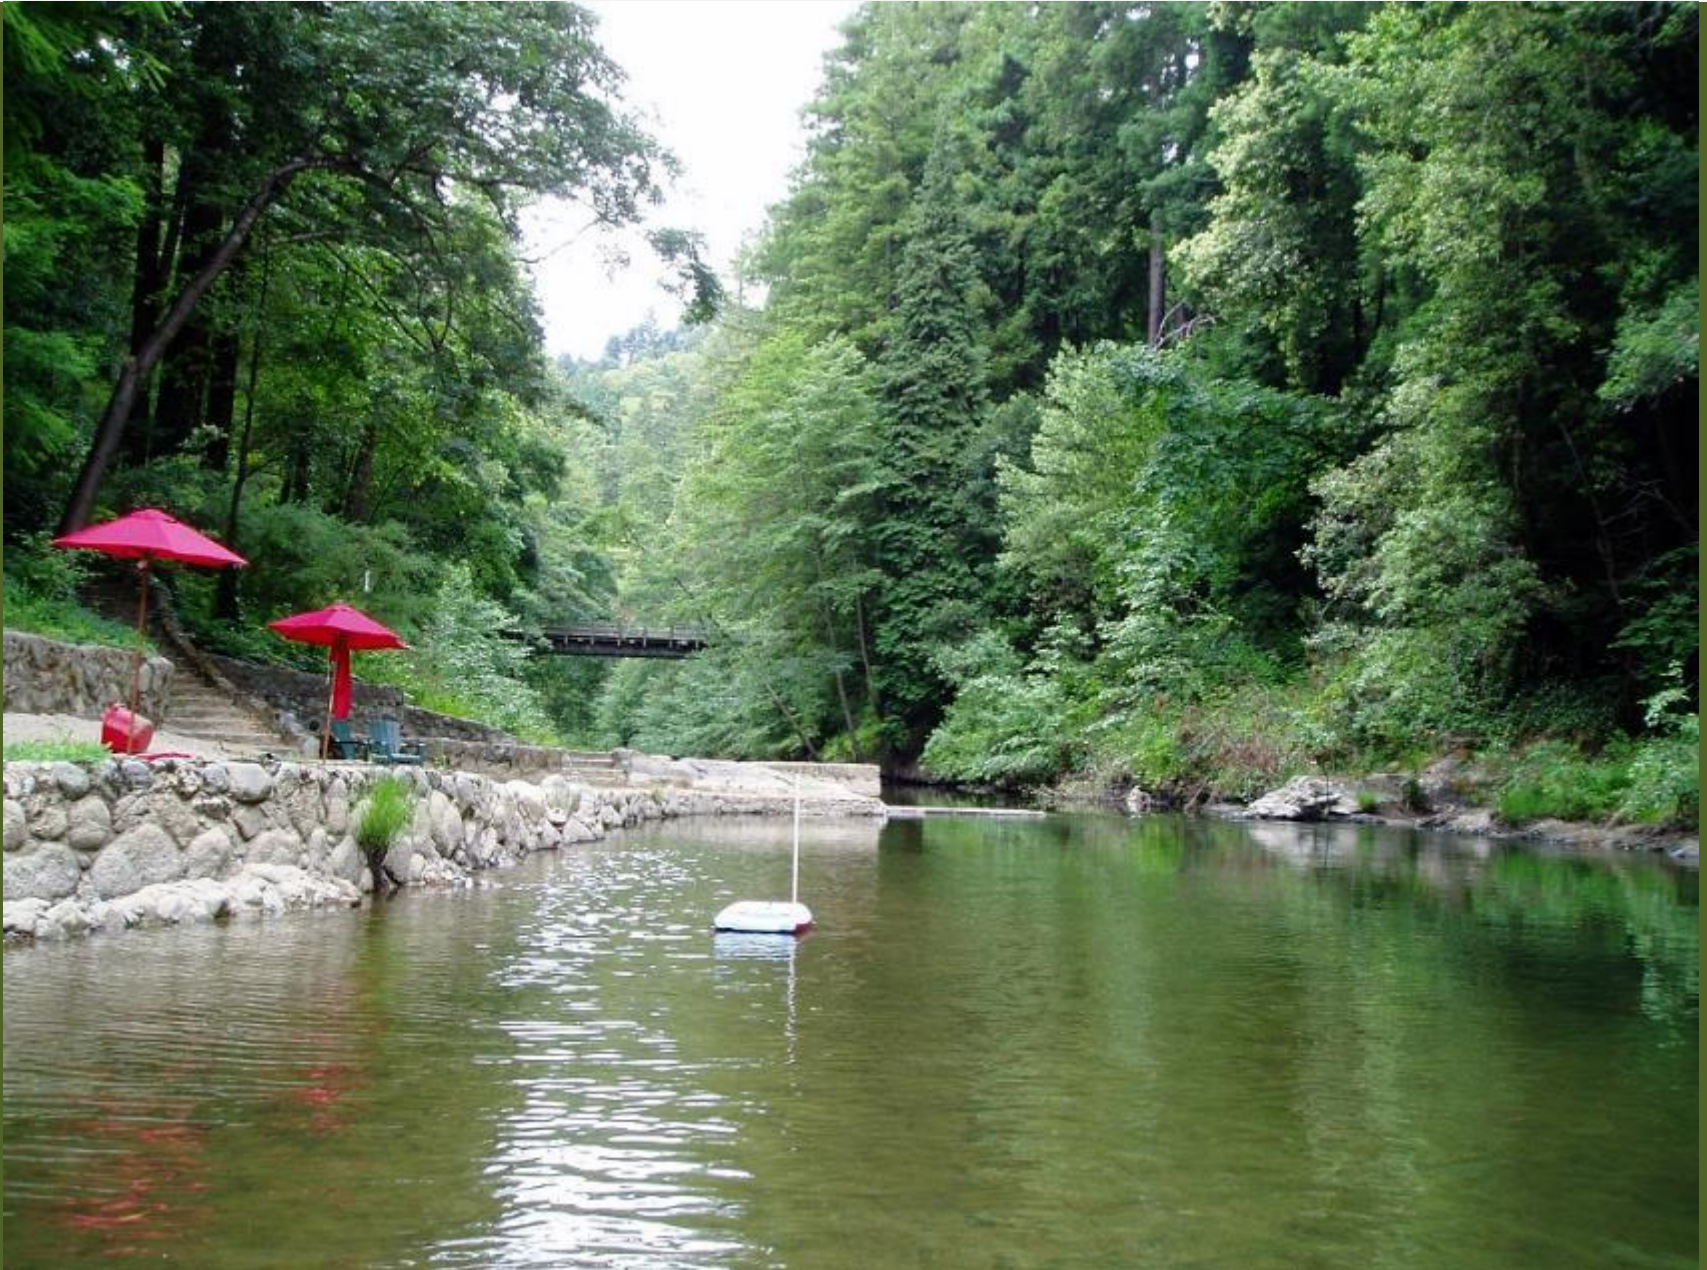
Larkspur Historical Structure #3

Severity: MEDIUM

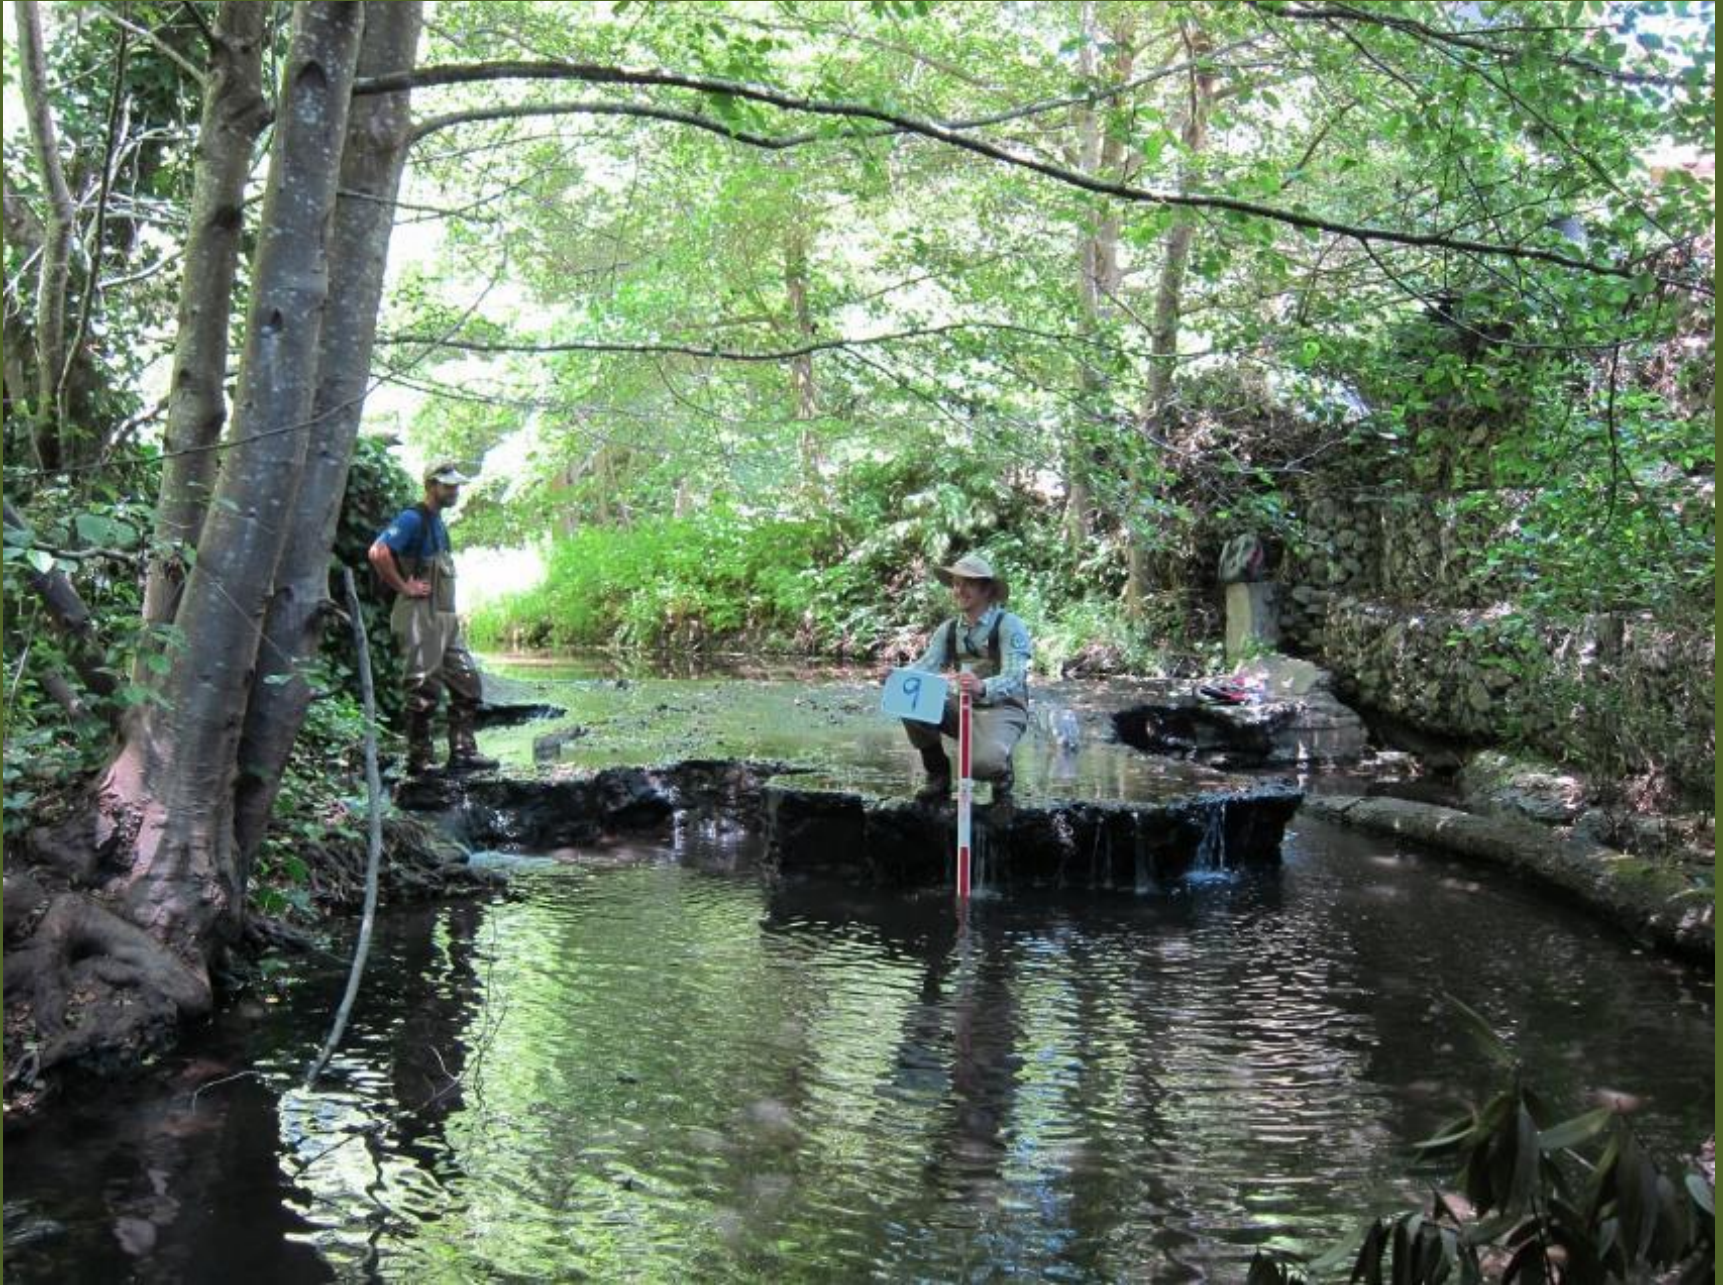
Either Way Historical Dam Remnant

Severity: HIGH
