Inventory of Historical Structures and Anadromous Fish Passage Conditions in the San Lorenzo River, Santa Cruz County, California

Final Report
November 8, 2023

Prepared by the County of Santa Cruz Water Resources Program,
Environmental Health, Health Services Agency

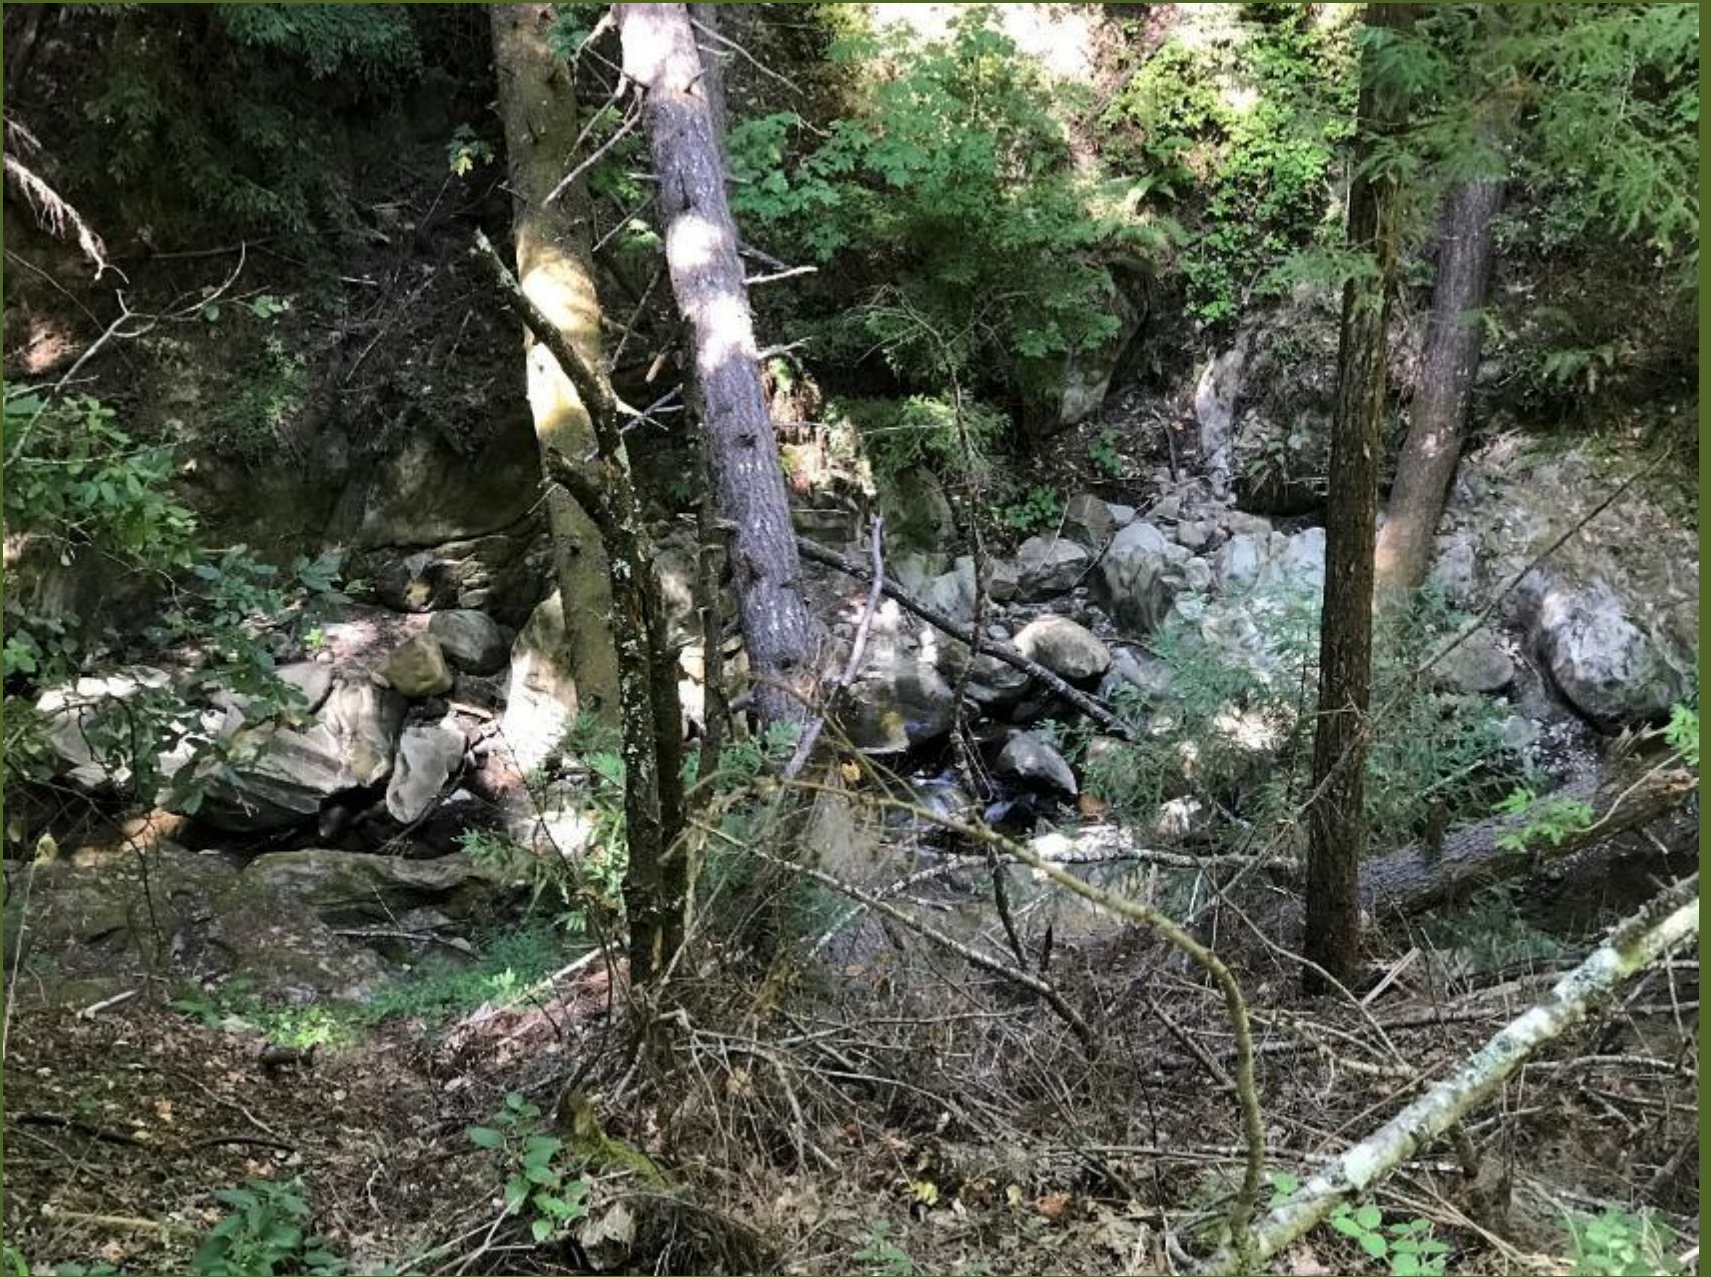
Riprap Jam: this area has a PAD ID for a barrier; no barrier currently present.

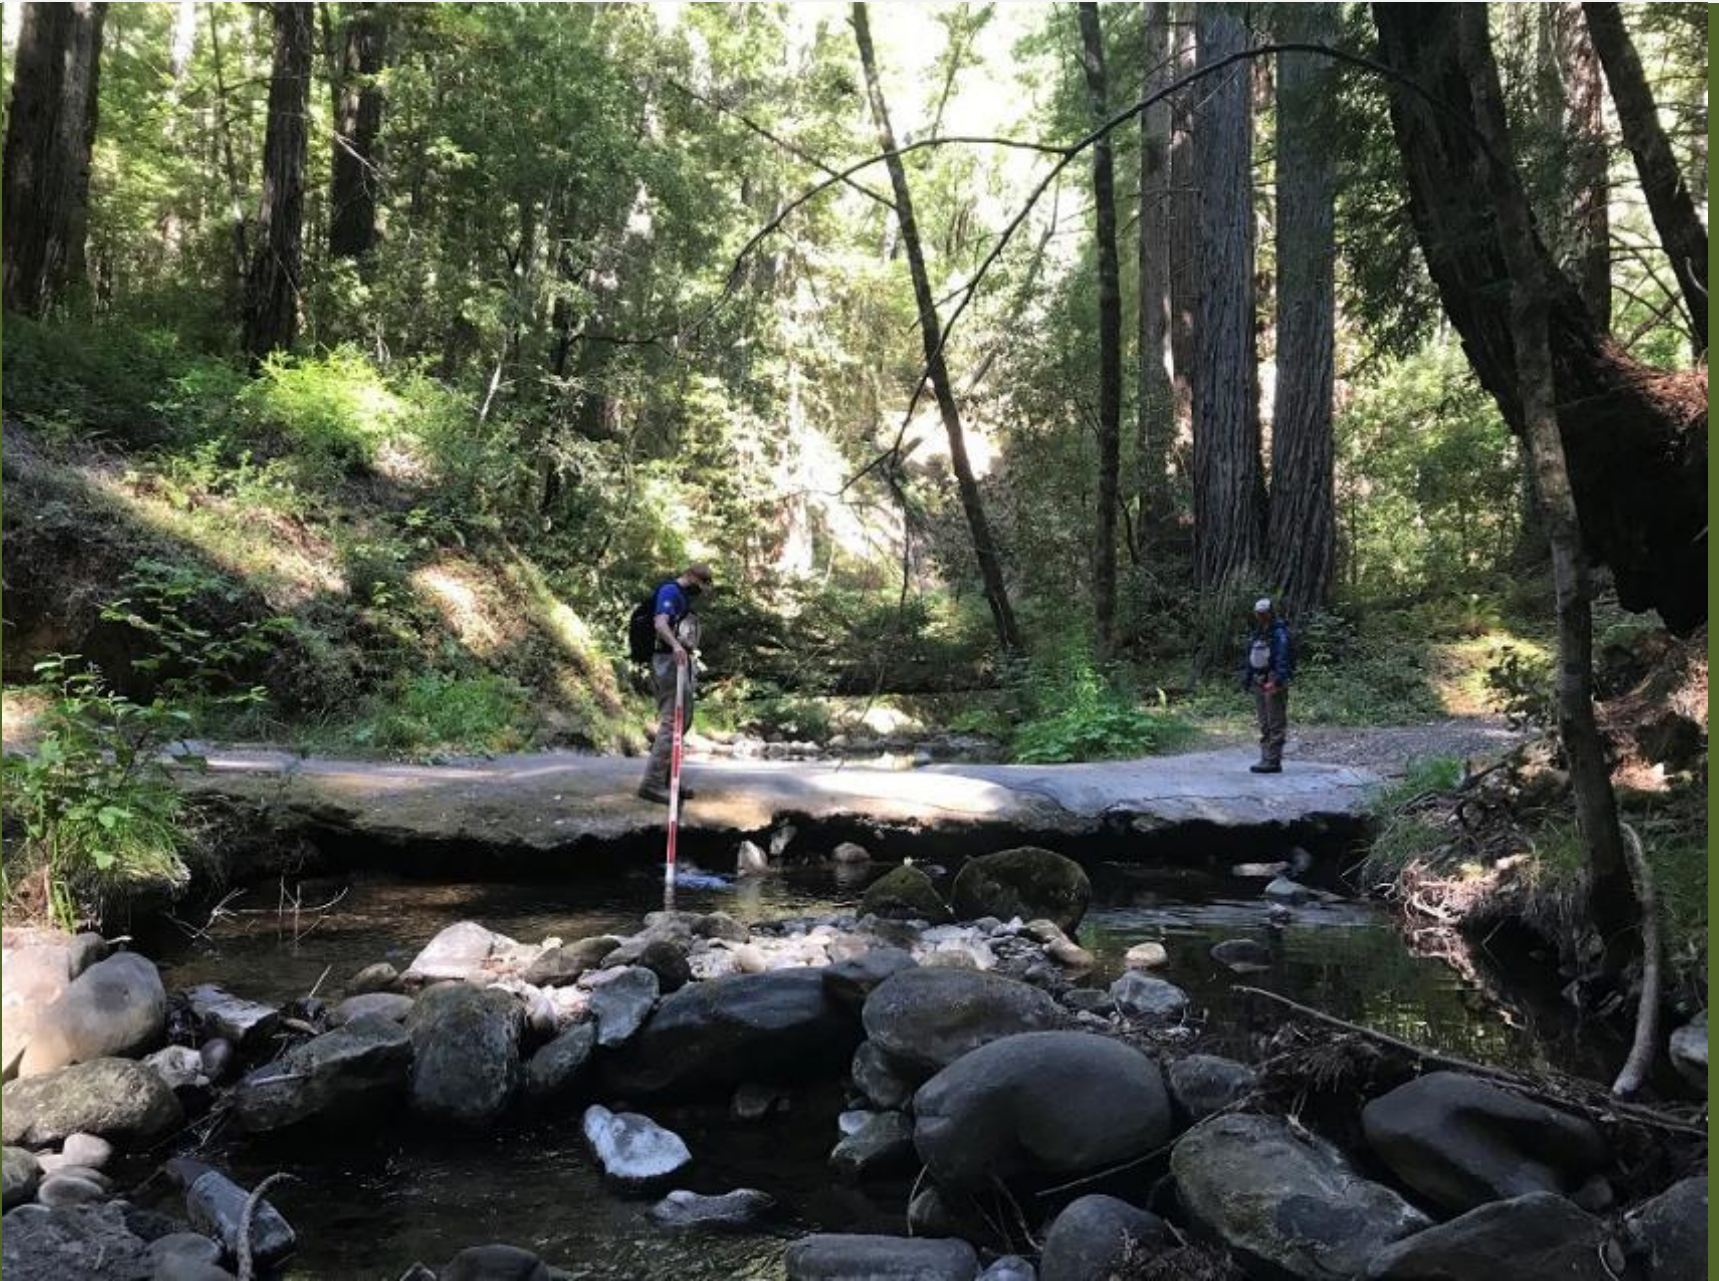
Kings Creek Truck Trail Ford

Severity: MEDIUM

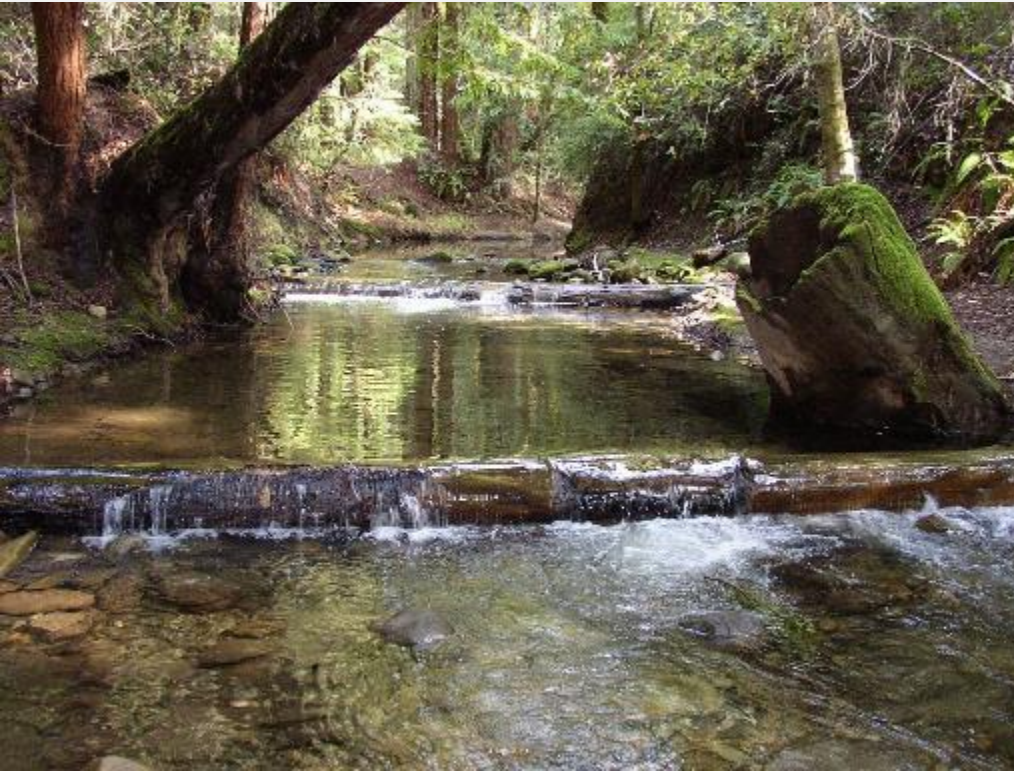
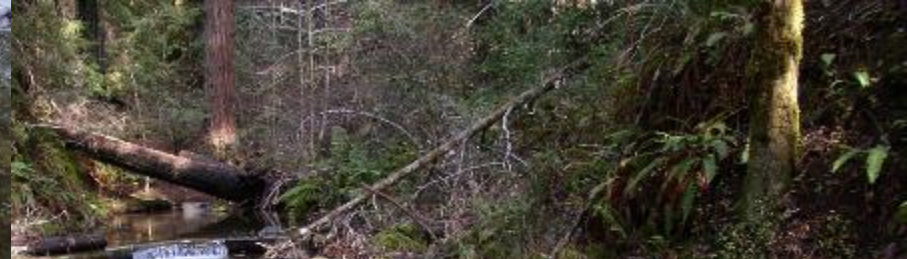
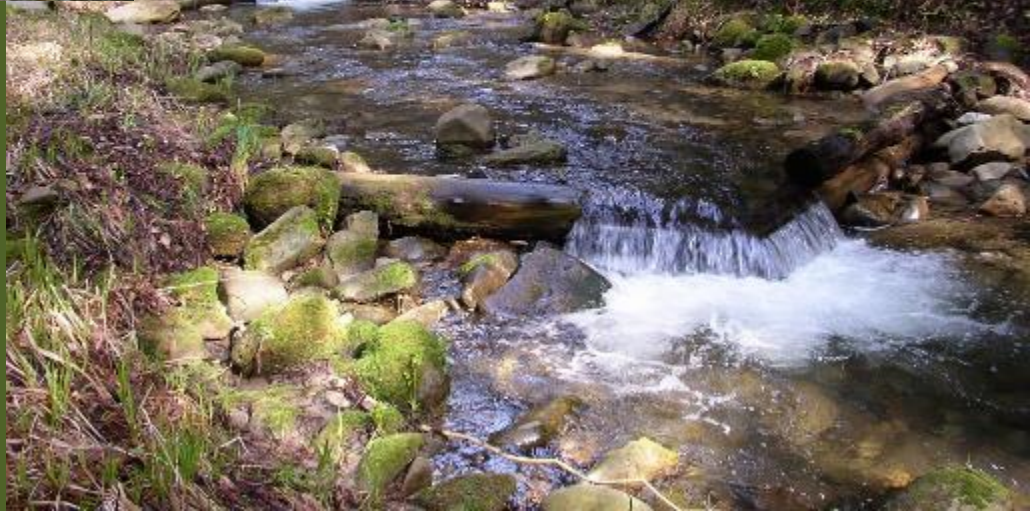
Waterman Gap - habitat enhancement structures

Upstream of the Kings Creek Truck Ford, within Castle Rock State Park, there are a series of 18 stream habitat structures. These structures were constructed in the late 1980's or early 1990's, when the property was owned by the San Lorenzo Valley Water District. The structures were constructed following CDFW Salmonid Restoration Habitat Manual designs and were intended to improve pool development by facilitating scour. Some of the structures have been successful at contributing to pool development but most of the structures are in poor condition and many are undercut by the river and inhibiting passage within this reach. A project could be developed to use a hand crew to cut out channel-crossing logs where the structures are in poor condition. The project could also remove frayed cable and loose fabric, which were used in the structure installation. Due to their remote location and small scale, these structures are grouped together and not individually geo-located.

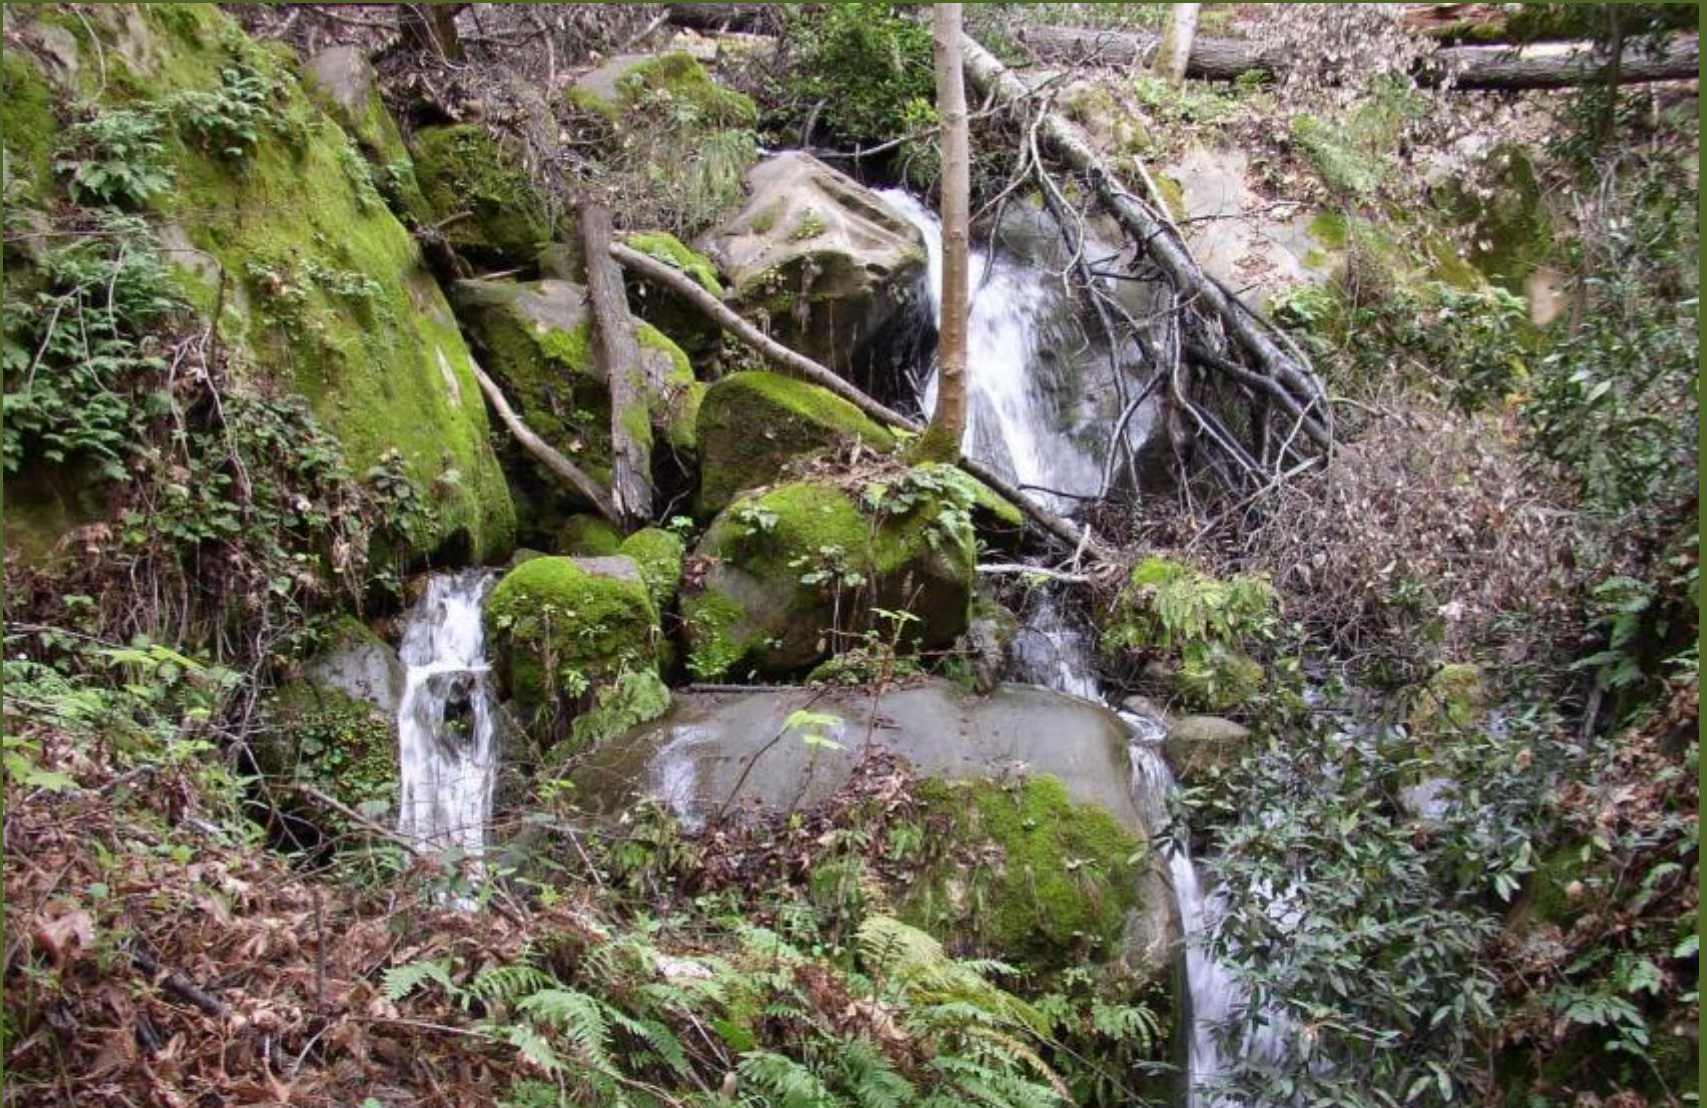
Waterfall

This boulder and bedrock cascade, approximately 40' high, is a complete barrier and the end of anadromy for the San Lorenzo River.
